Gillingwood Hall,  
near Richmond, North Yorkshire,  
and its historic garden:  
a final report

Scarborough Archaeological and Historical Society  
Report 69: 2026

National Grid Reference (approx centre) NZ 1710 0475  
National Grid Co-ordinates (approx centre) 41710 50475  
North Yorkshire HER No. 40333

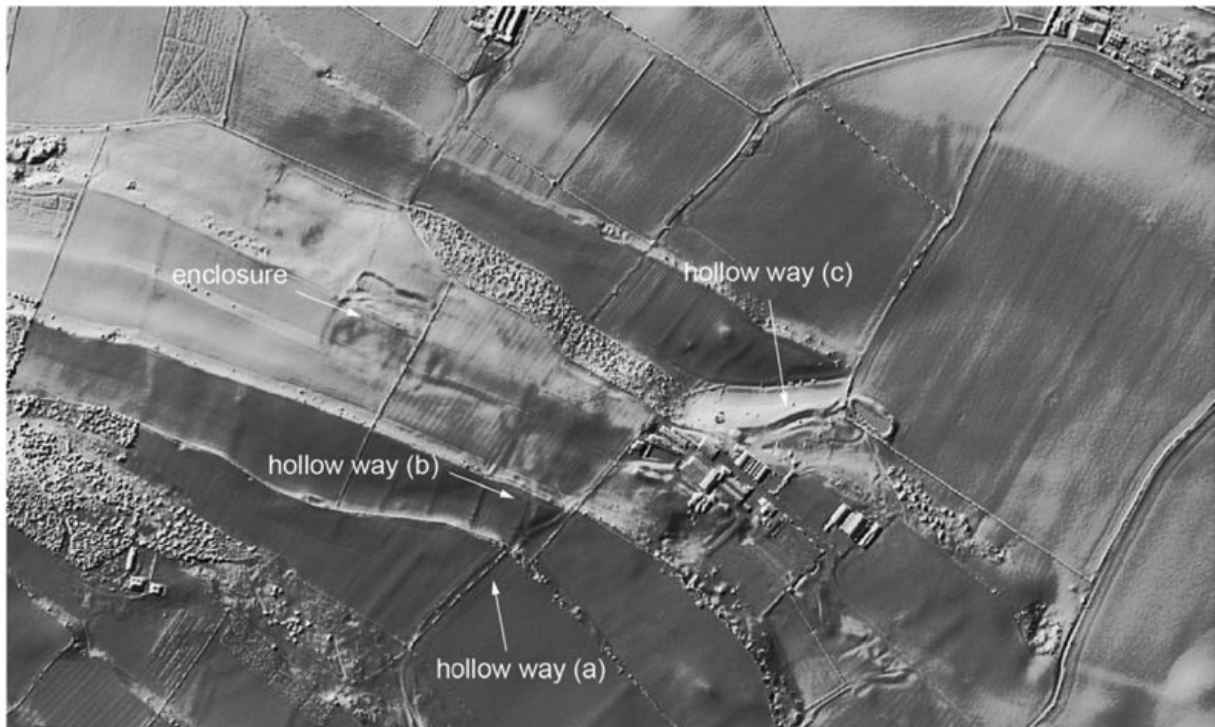
*Fig. 3 Lidar image based on Environment Agency data. (Map contains public sector information licensed under the Open Government Licence v3.0.).*

There is, however, clear evidence of earlier settlement and land use within a radius of 1km. For example, in a field called 'The Ashes', 500m NE of Gillingwood, at NGR NZ 166 049, there is a ploughed down earthwork, consisting of a sub-rectangular enclosure with dimensions of the order of 150m by 120m. This earthwork is visible on both lidar imagery and Google Earth, and is also apparent on the ground (Fig. 3).

The N side of the enclosure is formed by a substantial bank with an inner ditch but otherwise the enclosure is only intermittently visible as a residual earthwork. There appears to be an entrance in the E-facing side but no surface traces of occupation are apparent in the interior. Nevertheless, the size and shape of the enclosure suggest that it may represent a settlement of the late Iron Age or Roman periods.

The field immediately E of the enclosure has been rig ploughed in the post-medieval period as demonstrated by a pattern of straight, relatively narrow rigs visible on lidar. This ploughing has partially obliterated the earlier boundaries described above. To the SW of Gillingwood Hall a well-marked hollow way (Fig. 3, hollow way (a)) descends the hill before splitting into two branches, one of which turns towards the entrance in the E side of the enclosure (Fig. 3, hollow way (b)); the other continues downhill before disappearing beneath the farm buildings to the W of the Hall (Fig. 3, hollow way (c)). The hollow

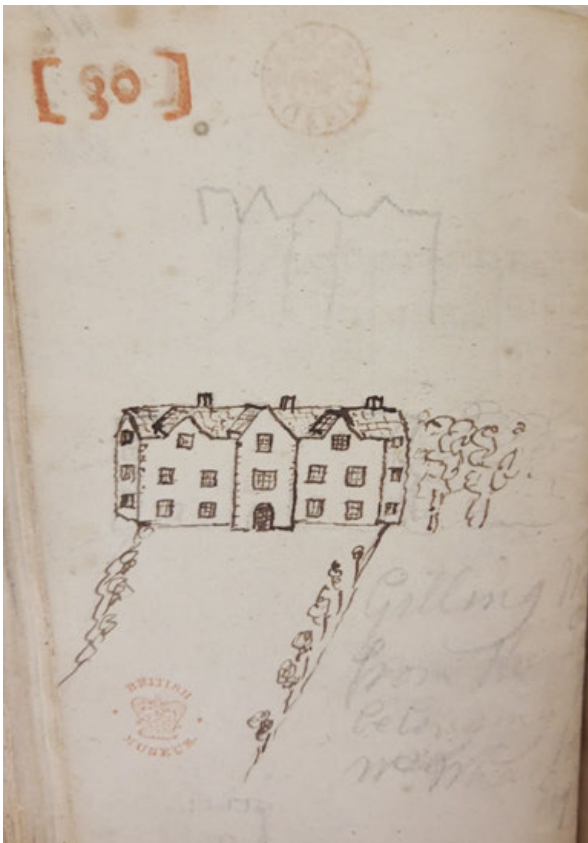
*Fig 6.  
John Warburton's thumbnail sketch of Gillingwood  
Hall, c. 1718. The British Library. Copyright The  
British Library Board.*

In one of Warburton's notebooks in the British Library there is a thumbnail sketch of Gillingwood annotated in pencil 'Gilling Wood from the East belonging to Mr Wharton Esq' (Fig. 6; British Library Lansdowne MS 911/4 f. 359d). This dispels any doubt there might otherwise be that it was the E front of the house that Buck drew. In other words, the Jacobean house faced E, whereas the later farmhouse faces N.

The enhancement using infra-red light has strengthened the two pairs of roughly parallel lines that run towards the viewer from either side of the fenced parterre in front of the house. In each case blobs or squiggles are shown spaced at regular intervals outside these lines. The double lines most probably represent either walls, hedges or fences, and the blobs trees or shrubs planted alongside them. These features are shown more clearly on the thumbnail sketch in Warburton's notebook referred to above (Fig.

6). In the right-hand boundary, close to the corner of the fenced parterre, Buck showed a gate, flanked by piers topped by ball finials. This is most clearly visible in the drawing enhanced by UV light (Fig. 8).

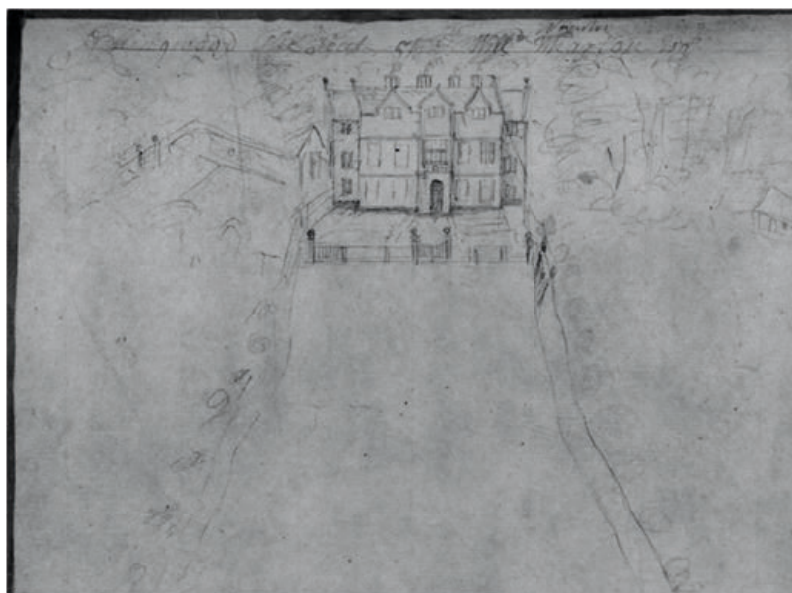
*Fig. 8.  
Buck's sketch enhanced with  
infra-red light. Image courtesy of  
Christina Duffy, The British  
Library. Copyright The British  
Library Board.*

To understand the drawing better, in March 2021 the British Library offered to enhance the image with the aid of multispectral analysis. Using combinations of infra-red and ultra-violet light, Dr Catherine Duffy, the Library's imaging specialist, produced a series of images which strengthen the pencil and ink components to varying degrees (Fig. 7 & 8). The most revealing of these images were those taken under infra-red light which reveal pencil marks that are now all but illegible under natural light (Fig. 8).

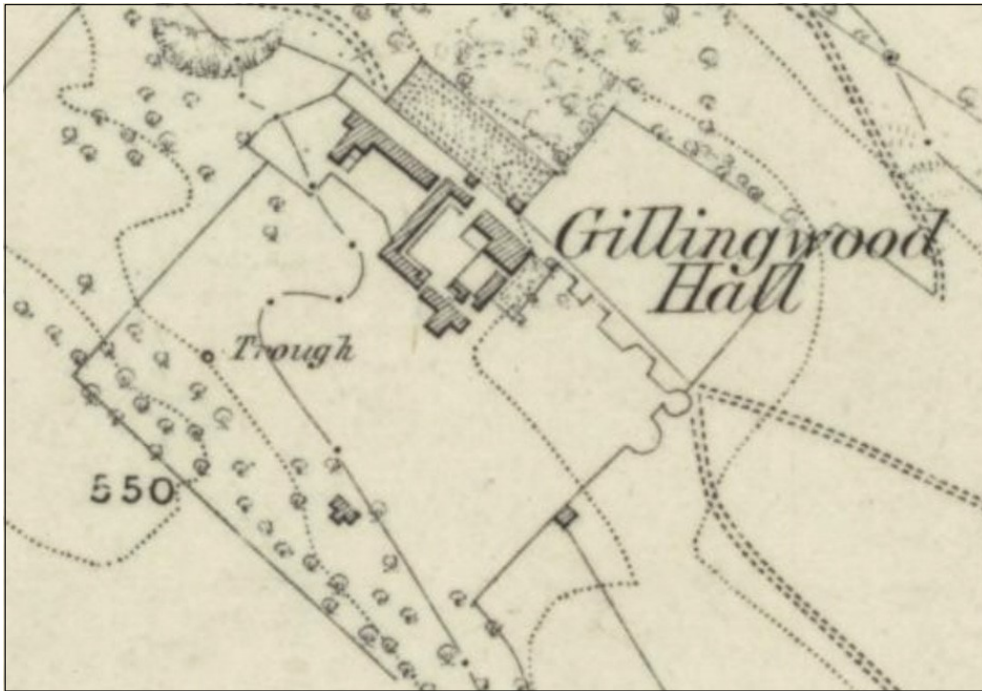
Fig. 9. Extract from the OS first edition of the six-inch map, surveyed in 1854/7.  
(Reproduced by permission of the National Library of Scotland).

The first edition of the OS six-inch (1:10,560 scale) map, surveyed in 1854 and published in 1857, is the earliest printed map to show Gillingwood Hall and its accompanying farm buildings accurately and to scale (Fig. 9).

What are presumably barns, animal sheds, cart houses and the like are arranged round a large yard to the W and S of the farmhouse. These include a detached, T-shaped building with a short arm projecting to the SW. Further to the NW is another range of buildings and beyond that a quarry.

The 1857 six-inch map also shows the pavilion, the temple-like 'summerhouse' and the bastioned retaining wall which bounds the formal garden on its NE and SE sides. The free-standing doorway on the lawn to the S of the farmhouse is not depicted, however, nor are the garden terraces.

The first edition of the OS six-inch map, surveyed in 1854 and published in 1857, shows that an extension had by then been built onto the north-west gable end of the farmhouse (Fig. 9). Similarly, by the time the first edition of the twenty-five-inch map was published, in 1893, a further block had been added at the rear (Fig. 10).

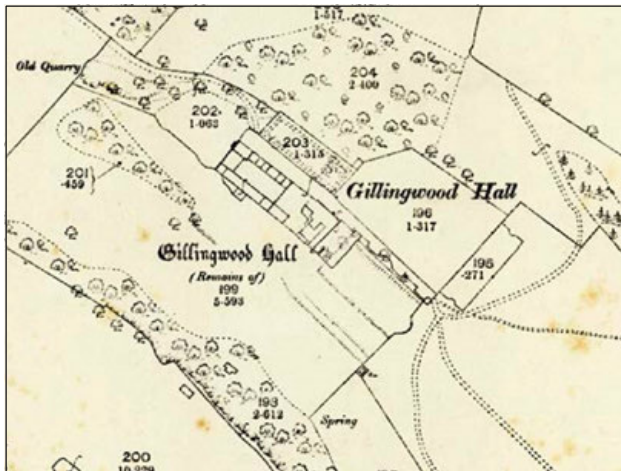
Fig. 10 (above)  
Extract from OS first edition of the twenty-five-inch map, 1892/3.

The garden terraces and the free-standing doorway make their first appearance on the first edition of the OS twenty-five-inch (1:2,500 scale) map, surveyed in 1892 and published in 1893 (Fig. 10). Interestingly, the words 'Gillingwood Hall (Remains of)', in antique type, appear alongside the name 'Gillingwood Hall', presumably to indicate that the surveyors had recognised the doorway and the terraces as the remains of the early house and its garden.

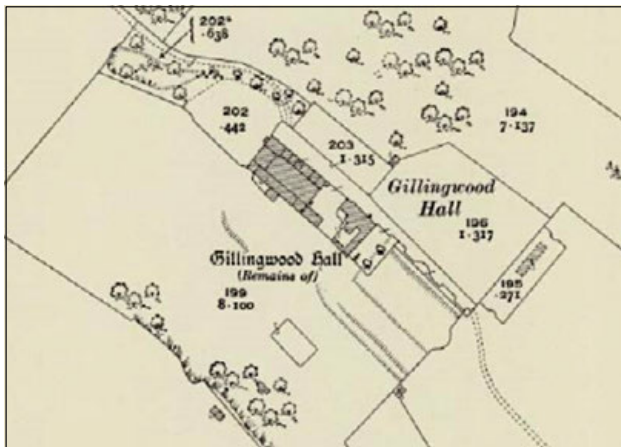
Fig. 11 (below)  
Extract from OS revised edition of the twenty-five-inch map, 1927/8.

A tennis court-sized enclosure, which occupies level ground half-way between the temple-like 'summerhouse' and the uppermost garden terrace, is first shown on the 1927/8 revision of the twenty-five-inch map (Fig. 11). No surface trace of it survives.

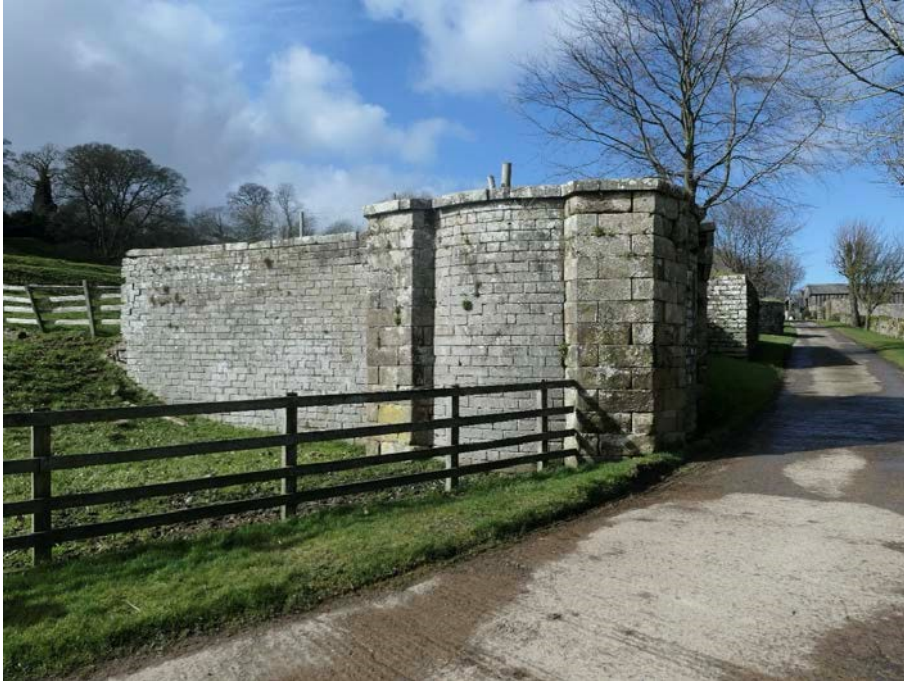
*Fig. 17 The corner turret and the bastioned wall beside the lane.*

Approaching Gillingwood along Old Hall Lane, the visitor is confronted by a massively-built bastioned stone wall which forms the perimeter of the garden on its SE-facing side (Fig. 17). Standing to a maximum height of 3.5m at the turret on the corner, the wall is built of neatly coursed ashlar blocks with prominent ridged tooling on their outer faces (Fig. 18).

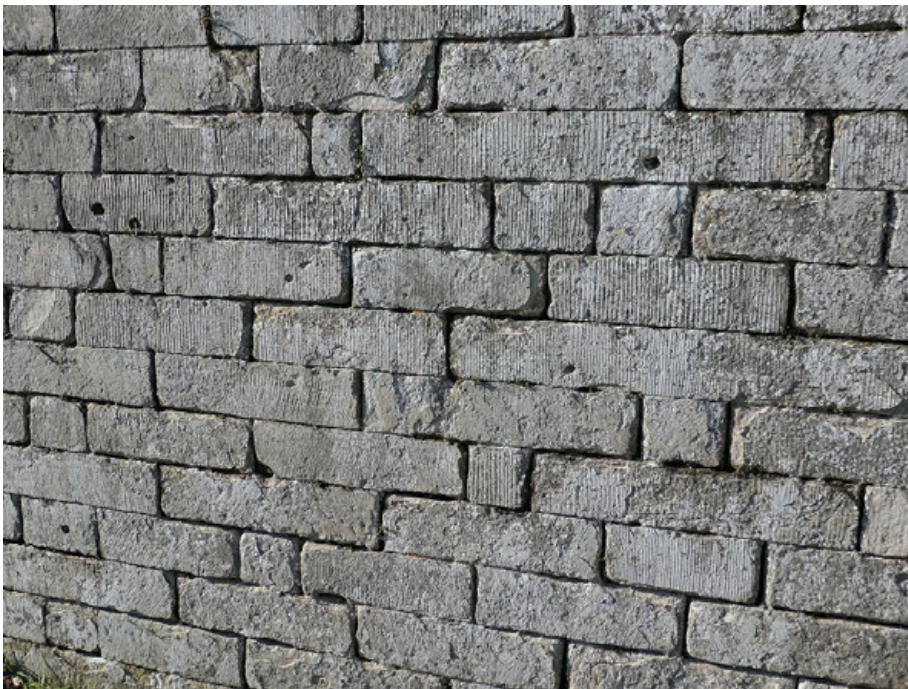
*Fig. 18 Ridged tooling on the ashlar masonry of the bastioned wall.*

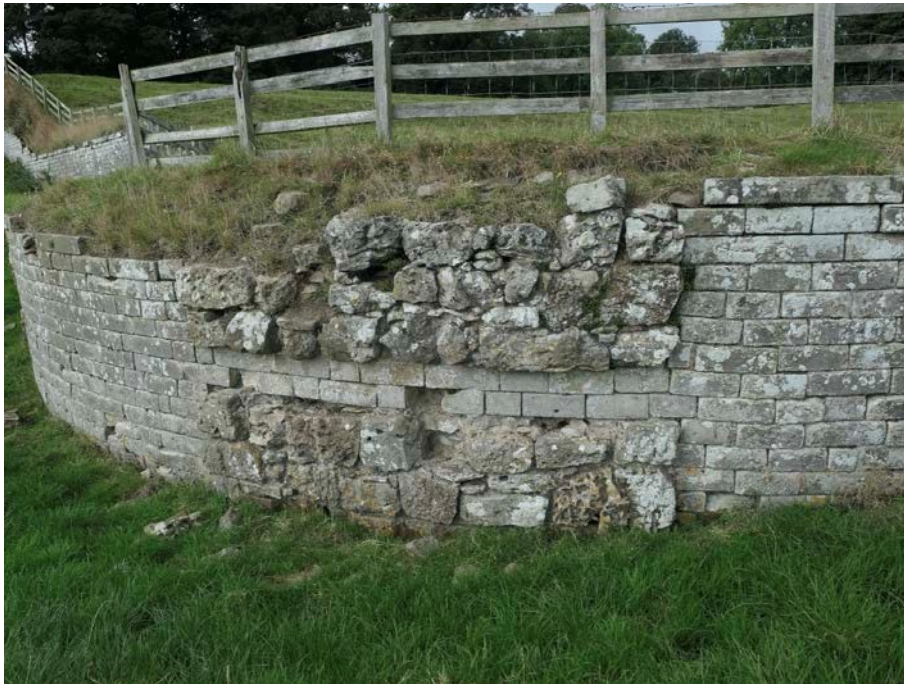
*Fig. 19*

*Bands of rusticated masonry in the half-moon bastion.*

Between the corner turret and the pavilion, a half-moon bastion, embellished with bands of ‘wild’ rusticated stonework, projects outwards from the wall (Fig. 19).

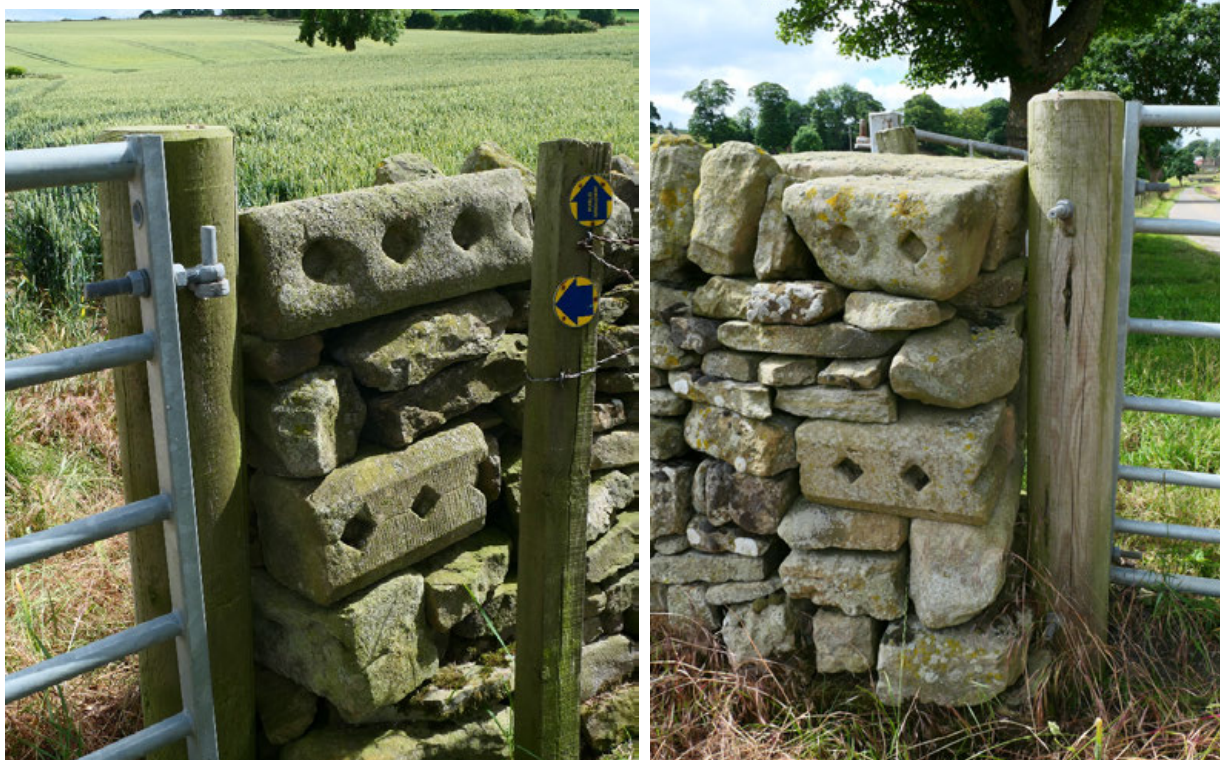
*Figs. 20 & 21. Ashlar blocks with diamond-shaped incisions re-used as decorative elements in modern field gateways.*

Several field walls and gateways in the vicinity of Gillingwood contain ashlar blocks with diamond-shaped slots cut into them (Figs. 20 & 21).

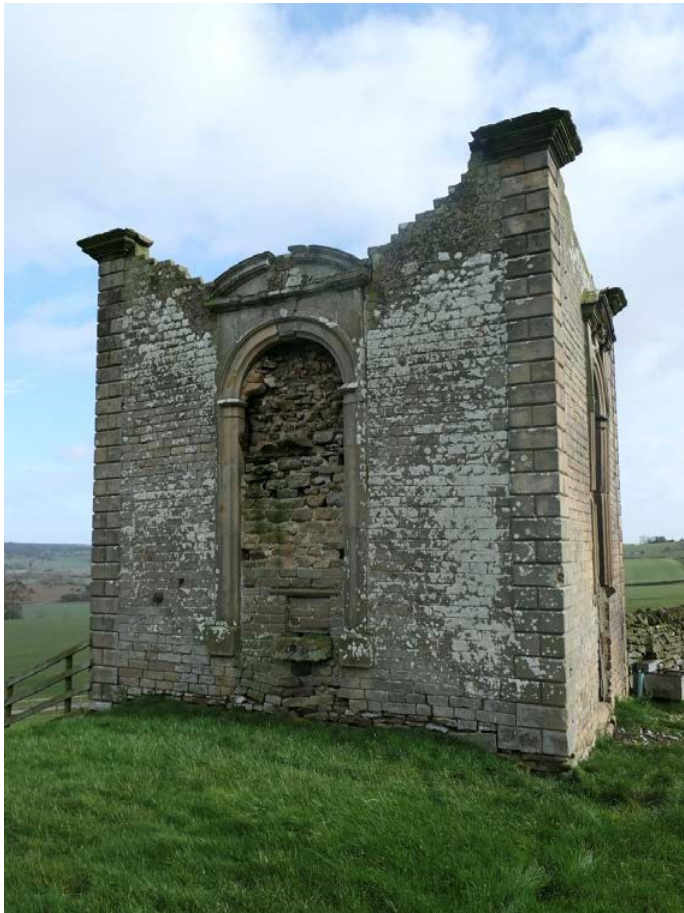
*Fig. 24 The blocked doorway of the 'Bell Park' pavilion or tea-house.*

The pavilion, or tea-house, is prominently situated on a high point overlooking the garden to the N. (Fig. 24).

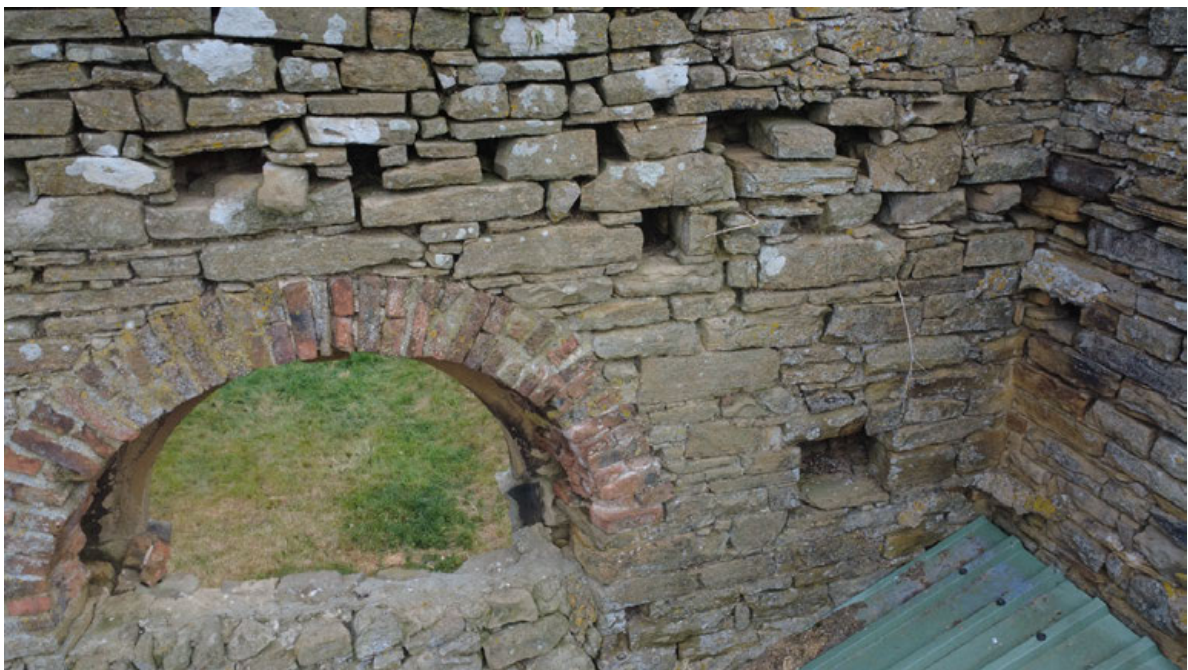
*Fig. 25 Interior view of the tea house showing a window opening under a brick arch. Above it are holes for joists which supported a flat roof. (Photo by Mark Denton).*

High up in the walls, holes on the inside of the N and S walls held joists supporting a flat roof (Fig. 25)..

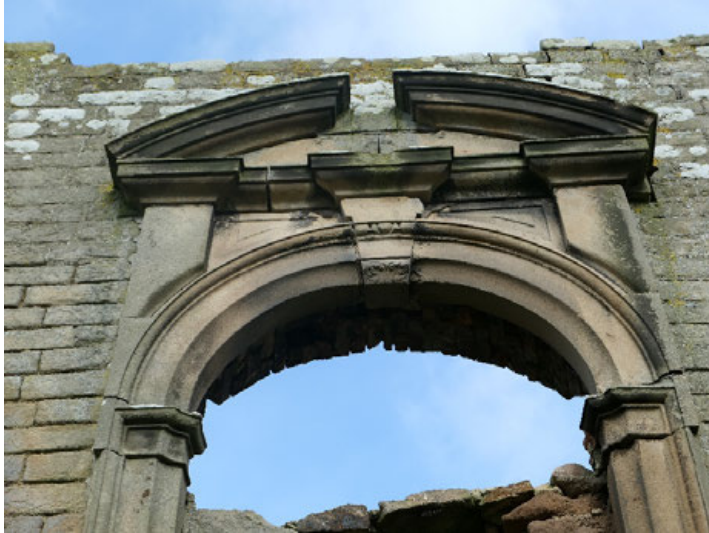
*Fig. 26  
Detail of the door opening on the W  
side of the tea house showing oak leaf  
decoration on the keystone of the arch*

Externally, the windows and doorway have identical frames topped by distinctive broken-arched pediments. The key-stones of the arched frames are decorated with stylised oak leaves (Fig. 26).

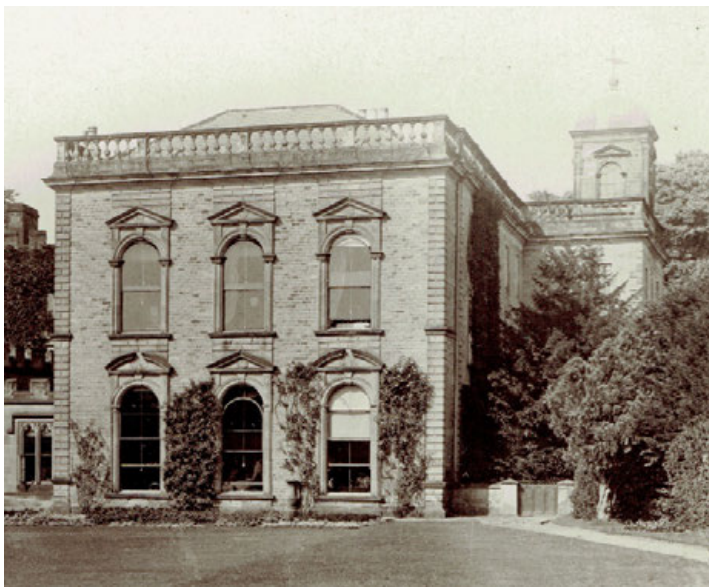
*Fig. 27  
Sedbury Park. The round-arched  
windows match those of the Gillingwood  
pavilion. Image supplied by Ed Kluz*

Before it was demolished, in 1927, there were windows with identical broken-arched pediments on the ground floor of the south wing of Sedbury Park, the home of the Darcy family (Fig. 27). While Sedbury Park is known to have been completed no later than 1718, it could date somewhat earlier than this and so closer to the proposed date of the Gillingwood pavilion. In any case, the same architect must surely have been involved in both projects.

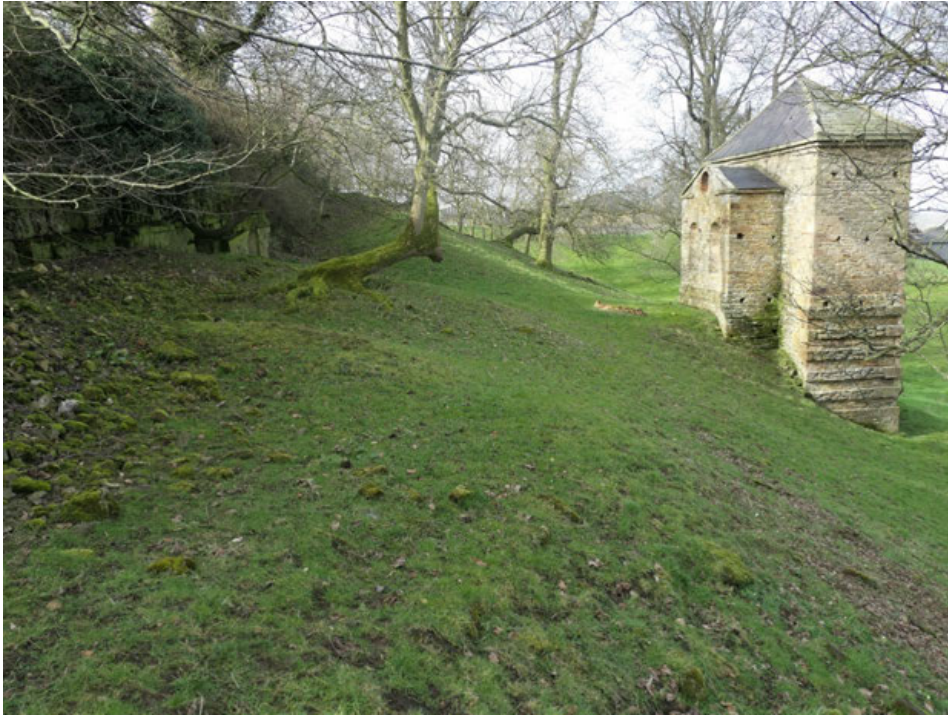
*Fig. 28 Showing the linear quarry along the escarpment edge behind the temple-like folly or 'summerhouse'*

The temple-like 'summerhouse' or folly overlooks the garden from a position high up on a steep slope to the S of the formal garden. Above and behind it, a quarried outcrop forms the crest of an escarpment (Fig. 28).

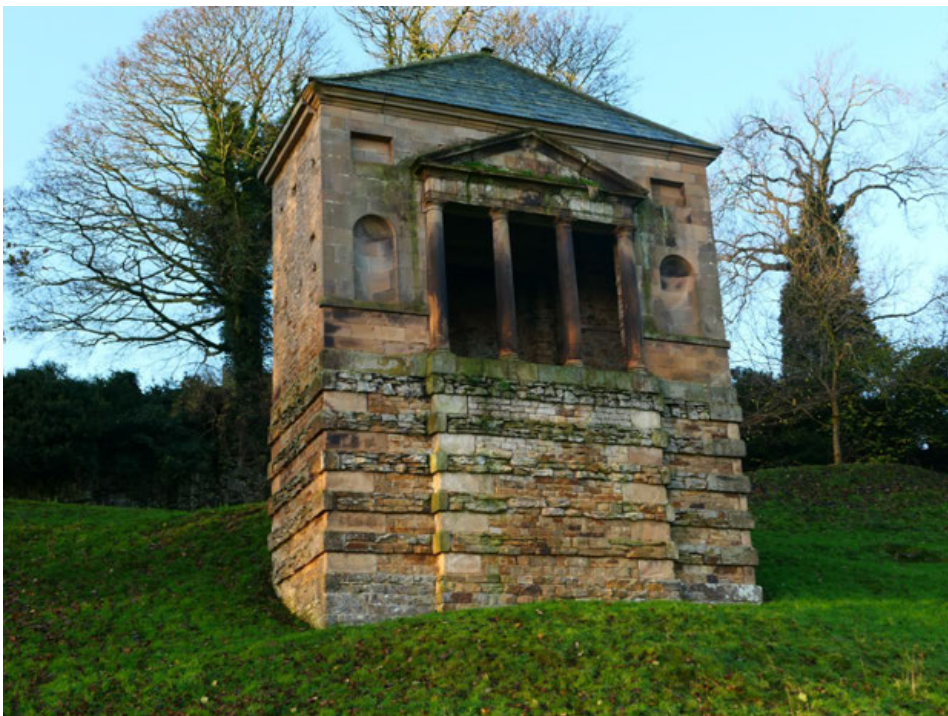
*Fig. 29 The temple-like folly or 'summerhouse'.*

The folly is of three bays, the central bay projecting slightly forward. It stands on a tall basement composed of alternating bands of coursed ashlar and rusticated masonry (Fig. 29). The ashlar quoins at the corners are not symmetrical when seen from the front – on one side they are end-on to the viewer and on the other sideways on. Richard Pears wonders if this was deliberate or due to a misunderstanding of the architect's intentions by the local masons?

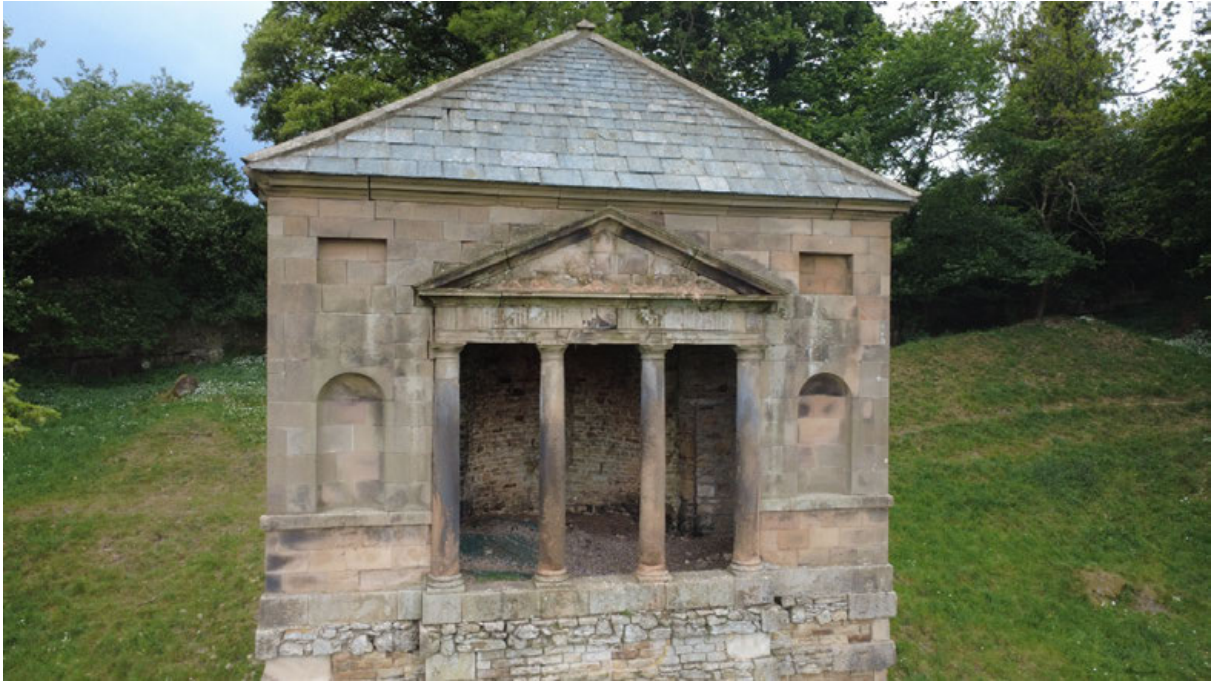
*Fig. 30 The curved rear wall of the folly is only dimly visible from the ground but is more clearly seen in this photograph taken with a drone. The blocked door in the back wall can just be made out between the two right-hand columns. (Photo by Mark Denton).*

In May 2025, Mark Denton, a professional photographer, flew a drone between the columns and took photographs of the interior of the folly, revealing features that cannot be seen from the ground outside, as shown on the sketch plan (Fig. 31).

The drone photographs confirm that the front part of the building is not bonded into the masonry at the back, demonstrating that it was built in two sections. The probable reason for this is that the basement, on which the forward part of the building stands, was built first, and the back part (which didn't require such a massive foundation due to the levelling off of the slope) was then added to it.

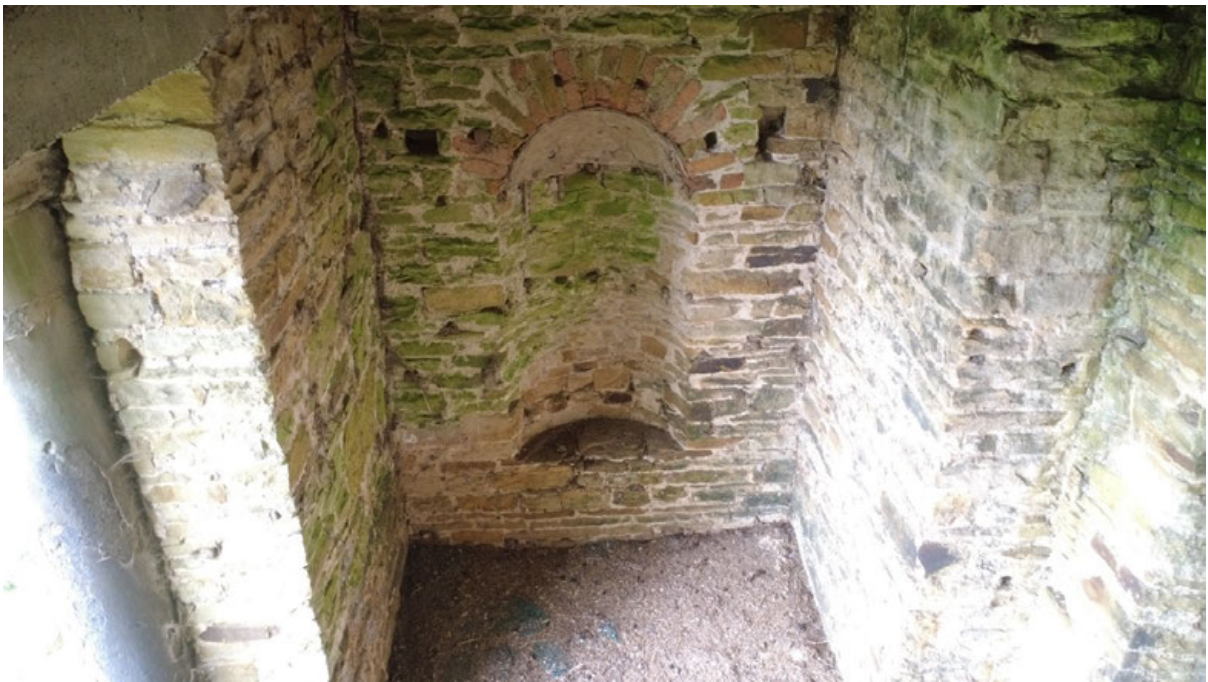
*Fig. 32 Niche in the west wall. Note the brick-arch at the top and in situ lathe and plaster below. Holes for wooden plugs are visible within the niche and in the walls on either side indicating that the interior of the folly was probably plastered. (Photo by Mark Denton).*

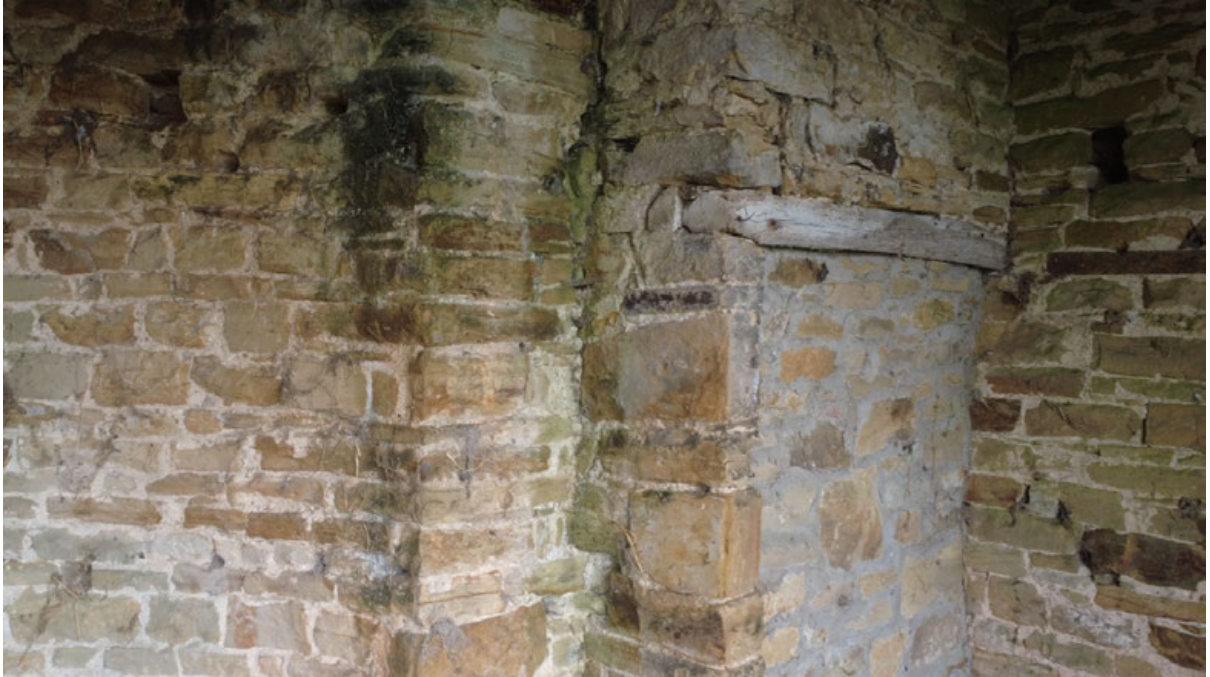
*Fig. 33 The blocked doorway in the SW corner of the main chamber. (Photo by Mark Denton).*

Access to the interior was originally via a narrow doorway in the SW corner (now blocked) (Fig. 33).

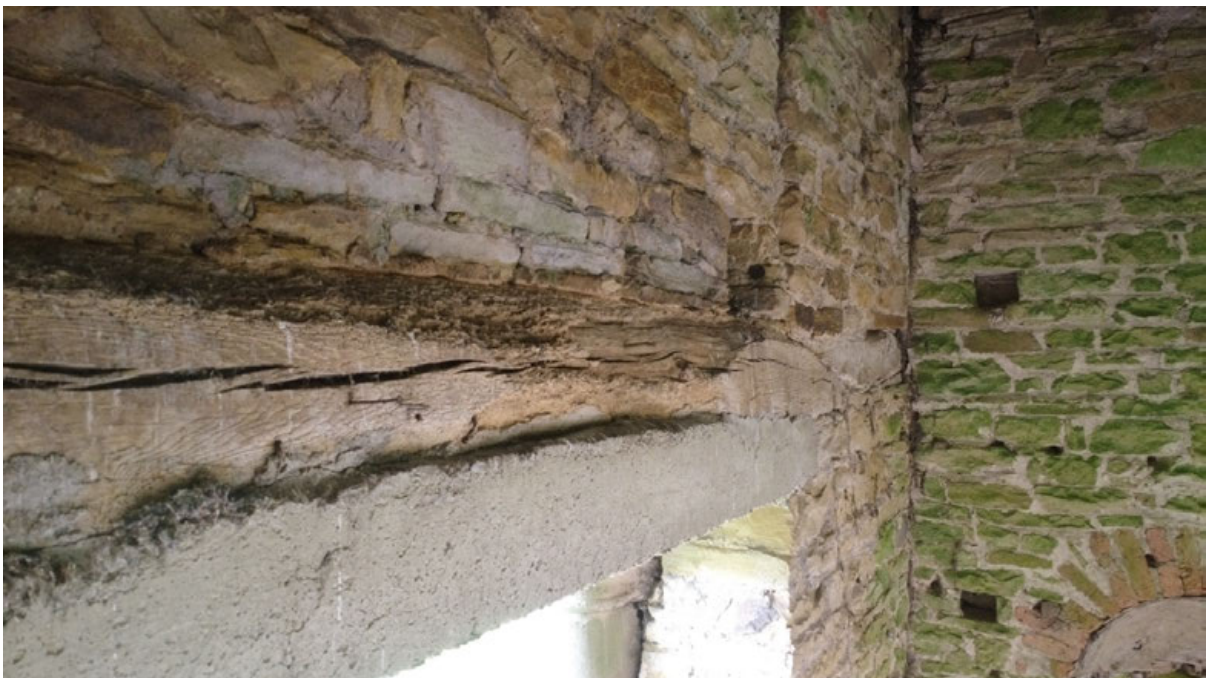
*Fig. 34 A poured concrete beam was inserted in the 1970's or '80s to support the wooden beam at the front of the building. (Photo by Mark Denton).*

The drone survey also revealed that extensive repairs have been made to the building. This work is said to have been carried out by a firm of local builders in the later 1970s or early '80s, at the same time as the folly was re-roofed.<sup>1</sup> For example, a poured concrete beam has been inserted under the old and worm-eaten wooden beam which supports the wall behind the pediment (Fig. 34); and a new wooden beam was put in place to bridge the gap between the walls on either side of the curved recess at the rear of the building (Fig. 35 ).

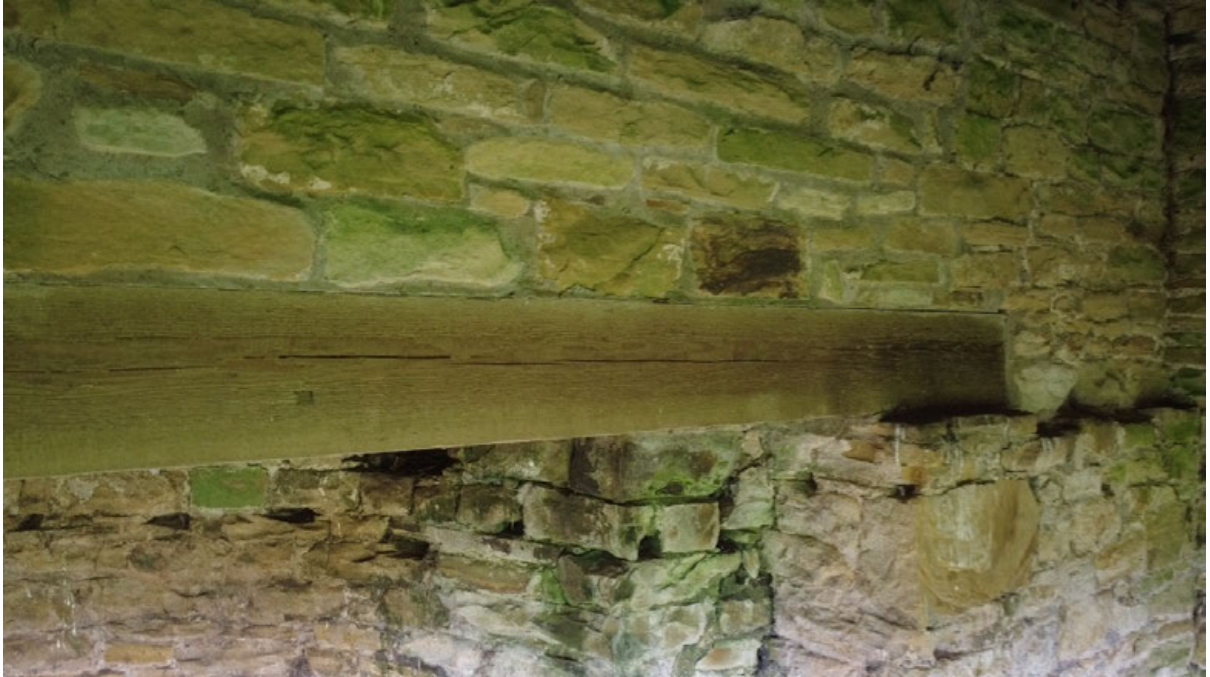
*Fig. 35 A new wooden beam supports a re-built wall at the back of the main chamber and in front of the projecting apsidal element. Note the regularly spaced holes in the masonry below which may have held wooden plugs to which lathes or battens were nailed. (Photo by Mark Denton).*

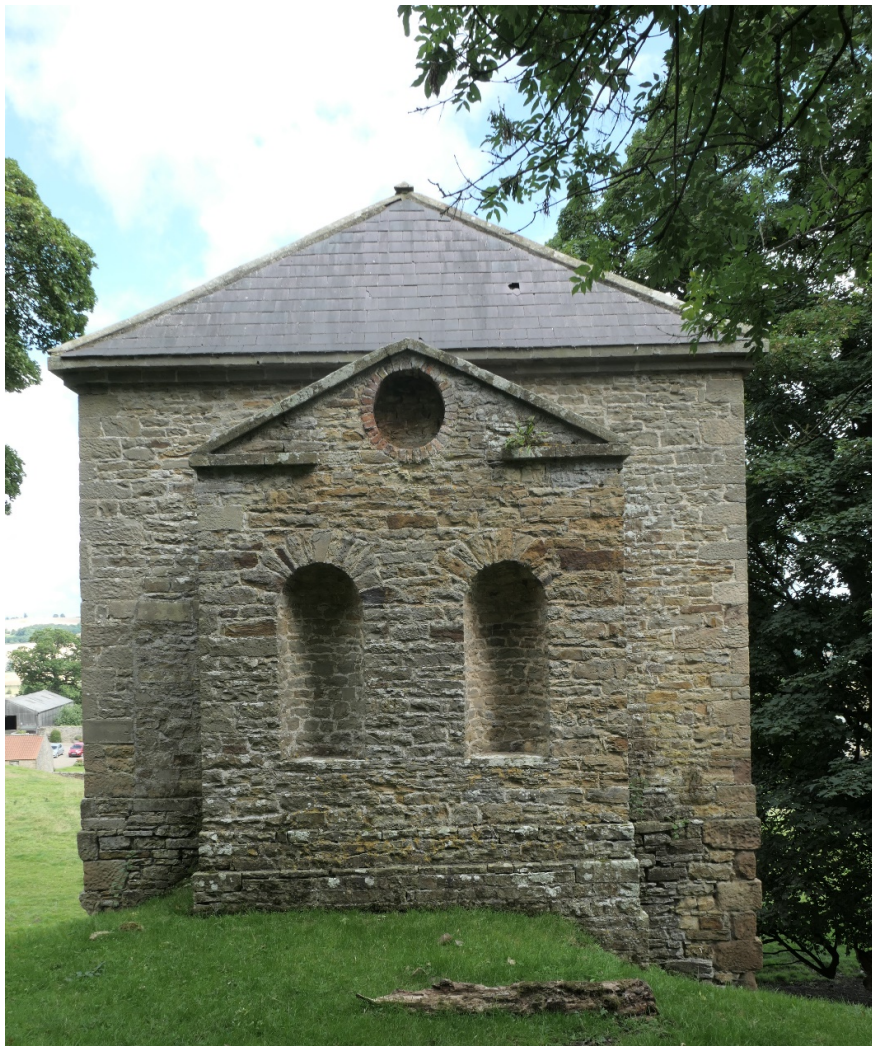
*Fig. 36 The folly, rear view.*

At the back of the building, a narrow range projects outwards to accommodate the apsidal structure within (Fig. 36). It is of coursed masonry embellished with two tall, round-headed, niches and a blind oculus edged in brick set into an open triangular pediment above.

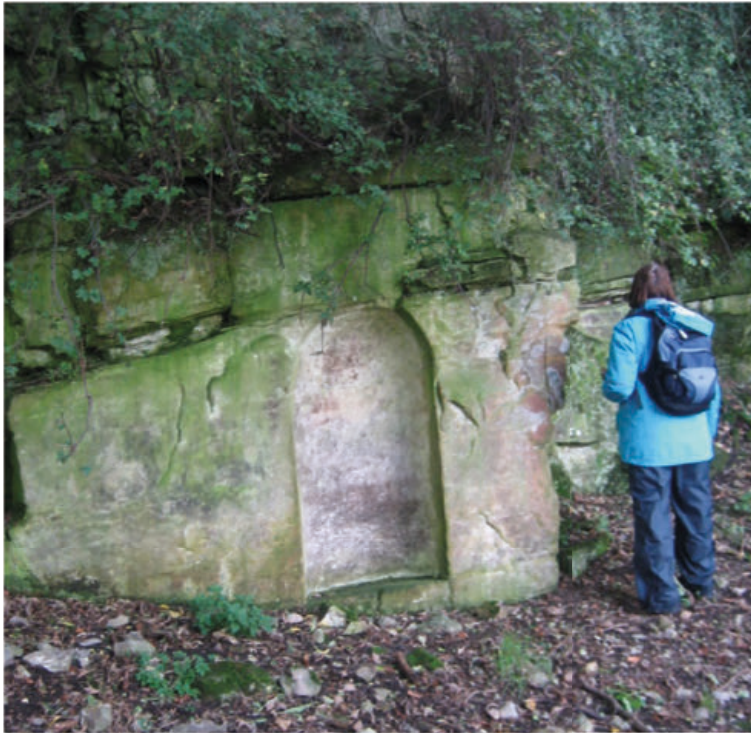
*Fig. 37  
Niche carved into the rock face  
behind the folly.*

Behind the folly, a round-headed niche has been carved into a vertical rock face produced by quarrying (Fig. 37). Although the quarrying cannot be precisely dated it is certainly older than the construction of the folly, as we shall see. The rock-cut niche mirrors the pair of niches in the rear elevation of the folly. As it is invisible from the garden below and has no obvious purpose, it may simply be a *jeu d'esprit* carved by the quarrymen.

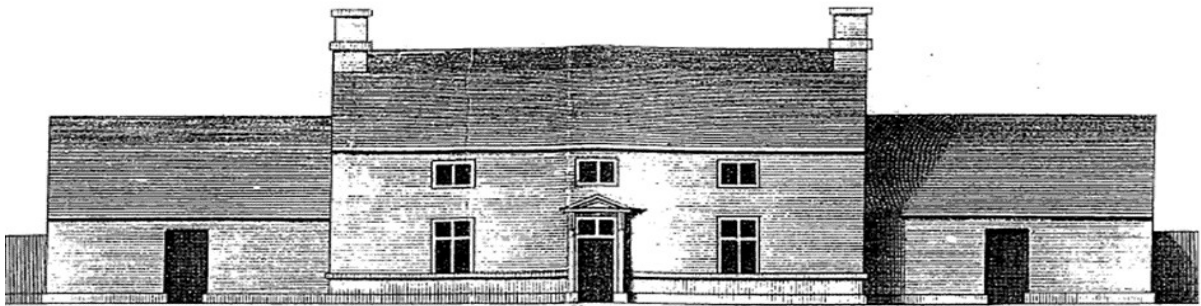
Fig. 38 Daniel Garrett's design for a farmhouse from *'Designs, and Estimates, of Farm Houses, &c for the County of York, Northumberland, Cumberland, Westmorland, and Bishopric of Durham'*, 2nd edn., 1759.

The design of the farmhouse that replaced the Jacobean hall derives from Daniel Garrett's book *'Designs, and Estimates, of Farm Houses, &c for the County of York, Northumberland, Cumberland, Westmorland, and Bishopric of Durham'*, first published in 1747 (Fig. 38).

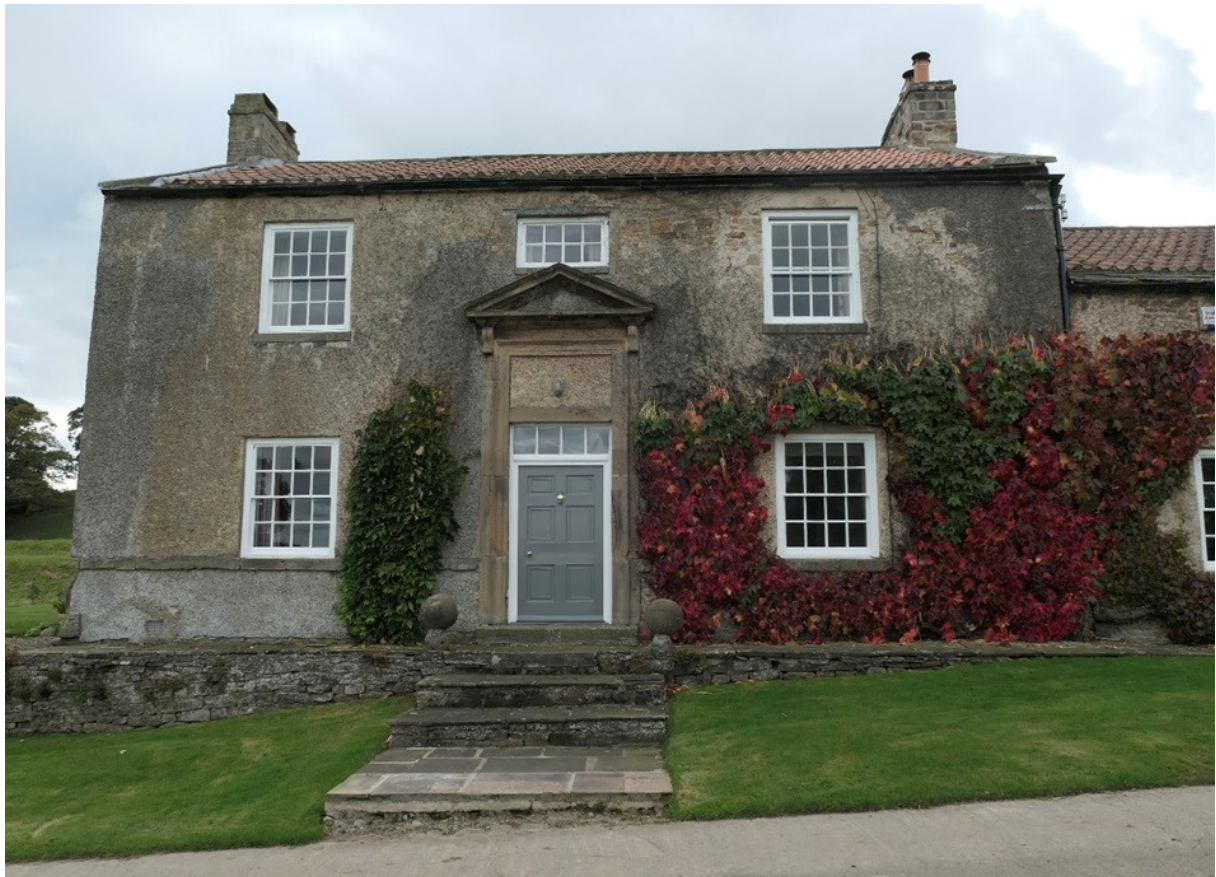
Fig. 39 The north-facing facade of the farmhouse. The string course and basal plinth extend the full width of the main façade beneath the Virginia creeper; Note the decorative stone balls which may originally have topped gate pillars belonging to the garden shown in Buck's drawing.

The oversized doorcase with its triangular pediment, the horizontal band surmounting a plinth course at the base of the facade, the fenestration and the chimneys in the gables, are all strongly reminiscent of Garrett's published design (Fig. 39).

Elsewhere on the site, pieces of architectural masonry, including decorative stone balls and stone from mullioned and transomed windows, have been re-used as decorative features in rockeries and flower beds (Fig. 39, 46, 47 & 48). Several such pieces were found in the 1960s when a rockery was built in the garden next to the lawn on the SW side of the farmhouse. It seems very likely this material represents rubble from the demolition of what remained of the Jacobean house after the fire. Probing with a garden fork suggests that there is a great deal more rubble buried under the upper lawn next to the farmhouse.

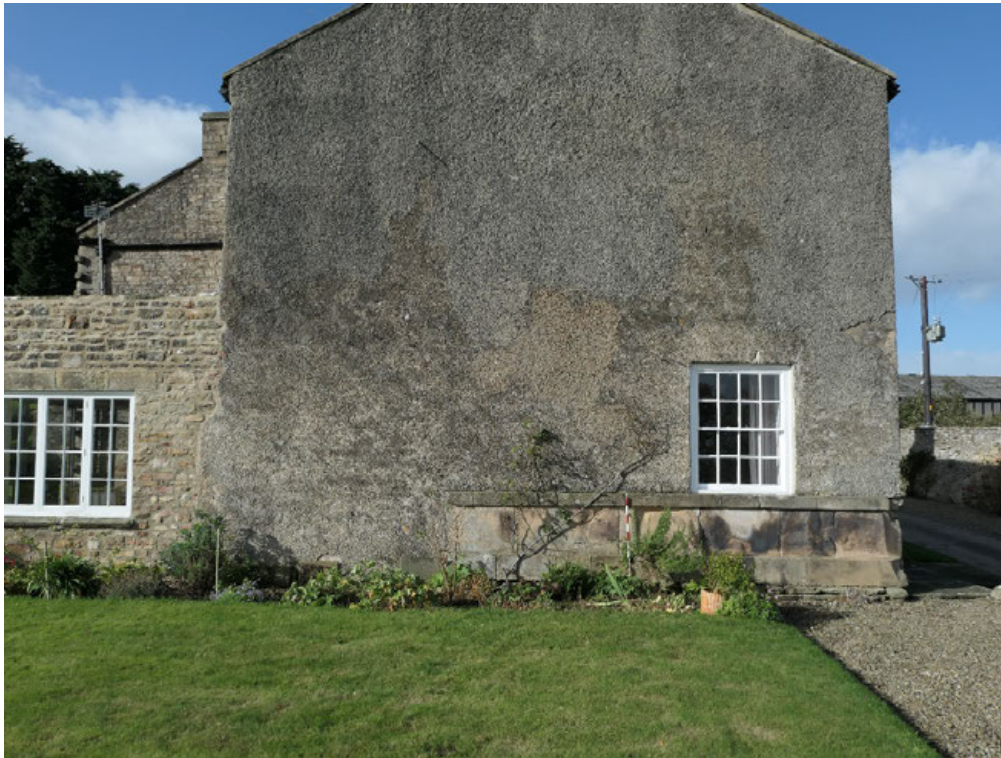
*Fig. 40 Plinth course extending part way round the gable end of the farmhouse.*

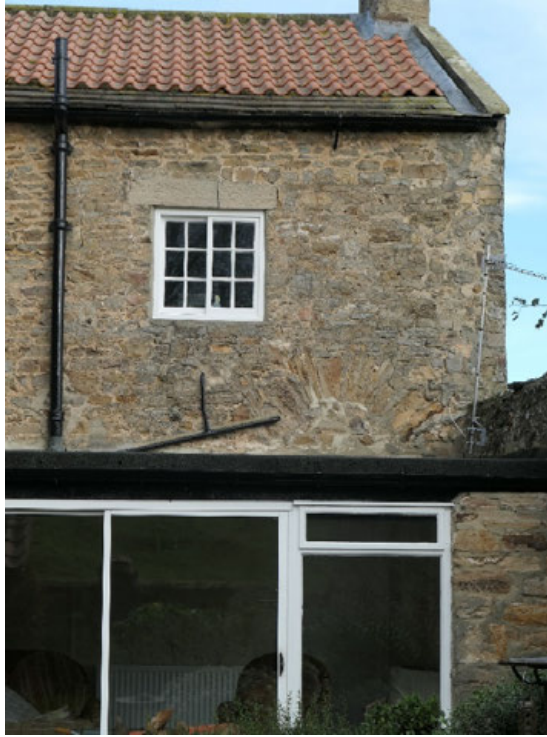
*Fig. 42 The relieving arch in the rear wall of the farmhouse.*

In the rear (SW) wall of the farmhouse, which is part of this U-shaped element, a relieving arch at first floor level is exposed in the masonry above a ground floor doorway but so high above it that it makes little sense in engineering terms (Fig. 42). Is this too evidence of a change of plan at some stage in the construction of the building?

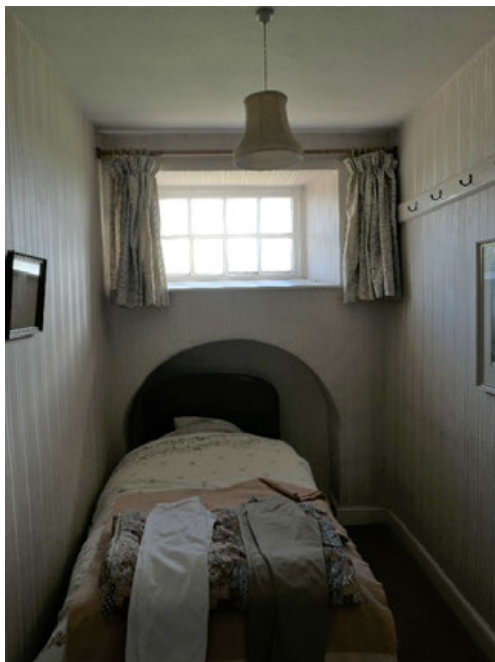
*Fig. 44  
Arched recess in the first-floor closet above the hall passageway*

Similarly, what is the significance of the odd arched recess in the front wall of the small, first floor closet above the entrance passageway? Is that too a relic of an earlier, unrealised plan? (Fig. 44).

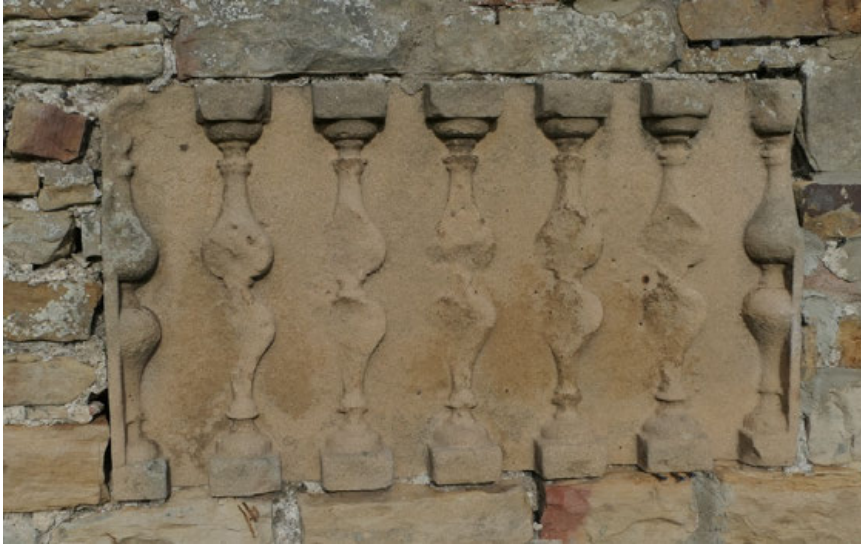
*Fig. 45 Demi-balustraded panel ex situ in an outhouse wall.*

There are other visible signs that the building we see now is not what was originally planned and that a different, and perhaps grander, building may have been intended. For example, what was the original destination of a demi-balustraded panel now set incongruously in the outside wall of a nineteenth-century outhouse? (Fig. 45).

The panel is *ex situ* and there is no knowing where it was destined to be used. In broad terms it dates to the mid-eighteenth century and comparable panels can be seen at Bradley Hall, co. Durham, c.1750, by Garrett; and at James Paine's temple at Bramham, West Yorkshire, c.1750-62. Is this, then, further evidence that Garrett may have been planning a larger and more impressive building than the existing farmhouse might suggest?
