Gillingwood Hall,  
near Richmond, North Yorkshire,  
and its historic garden:  
a final report

Scarborough Archaeological and Historical Society  
Report 69: 2026

National Grid Reference (approx centre) NZ 1710 0475  
National Grid Co-ordinates (approx centre) 41710 50475  
North Yorkshire HER No. 40333

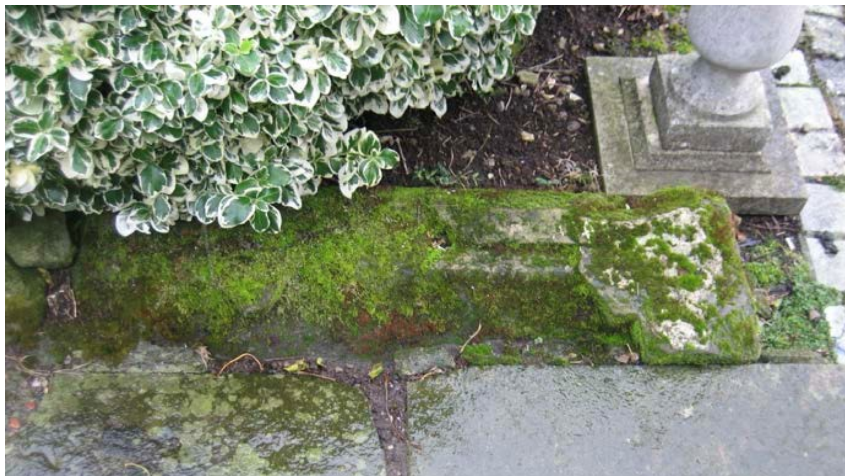
*Fig. 46  
The sill of a mullion  
window now re-used in a  
rockery outside the  
sunroom of the farmhouse*

Elsewhere on the site, pieces of architectural masonry, including decorative stone balls and stone from mullioned and transomed windows, have been re-used as decorative features in rockeries and flower beds (Fig. 39, 46, 47 & 48). Several such pieces were found in the 1960s when a rockery was built in the garden next to the lawn on the SW side of the farmhouse. It seems very likely this material represents rubble from the demolition of what remained of the Jacobean house after the fire. Probing with a garden fork suggests that there is a great deal more rubble buried under the upper lawn next to the farmhouse.

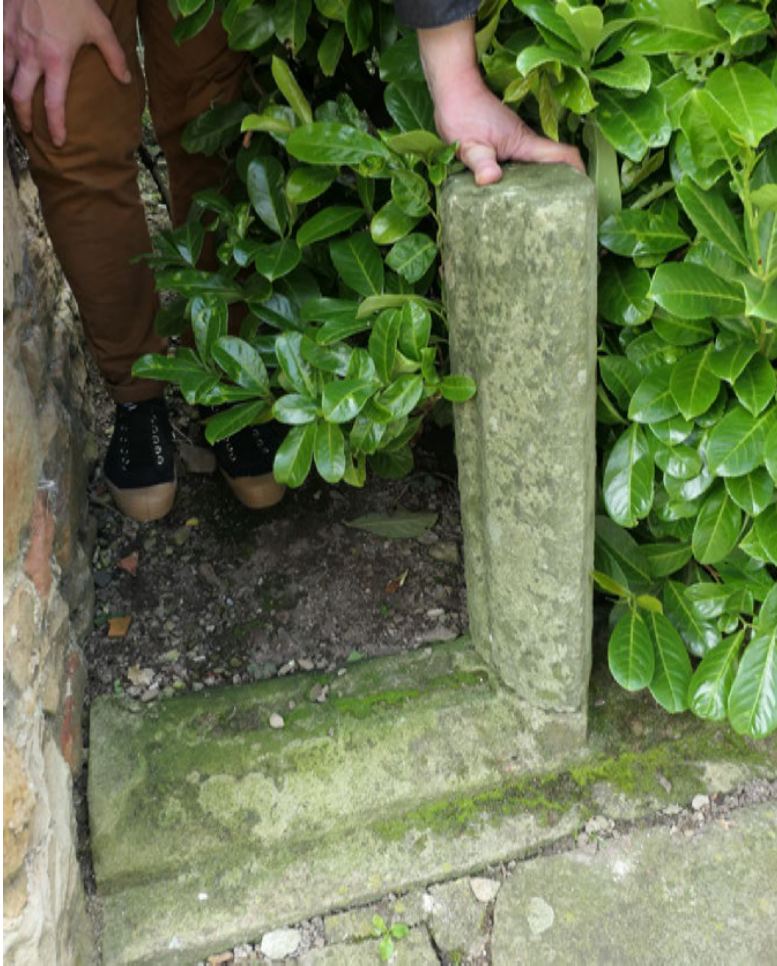
*Fig. 47  
Sill and mullion of window from  
the Jacobean house re-used in a  
rockery.*

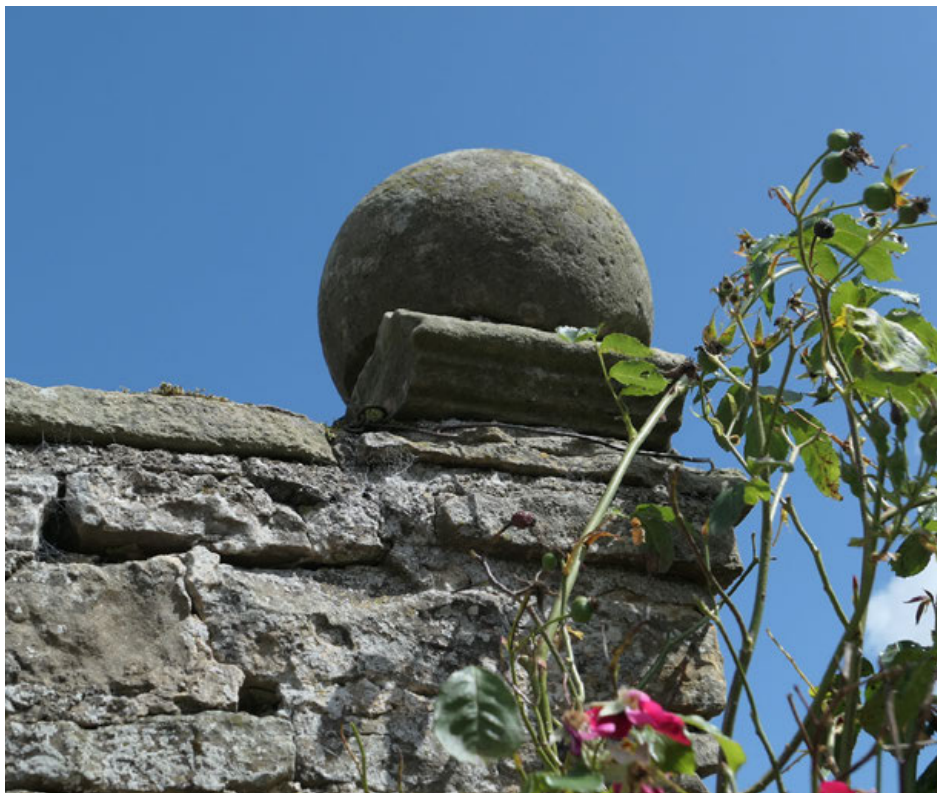
*Fig. 48 Decorative stone ball re-positioned on top of a garden wall.*

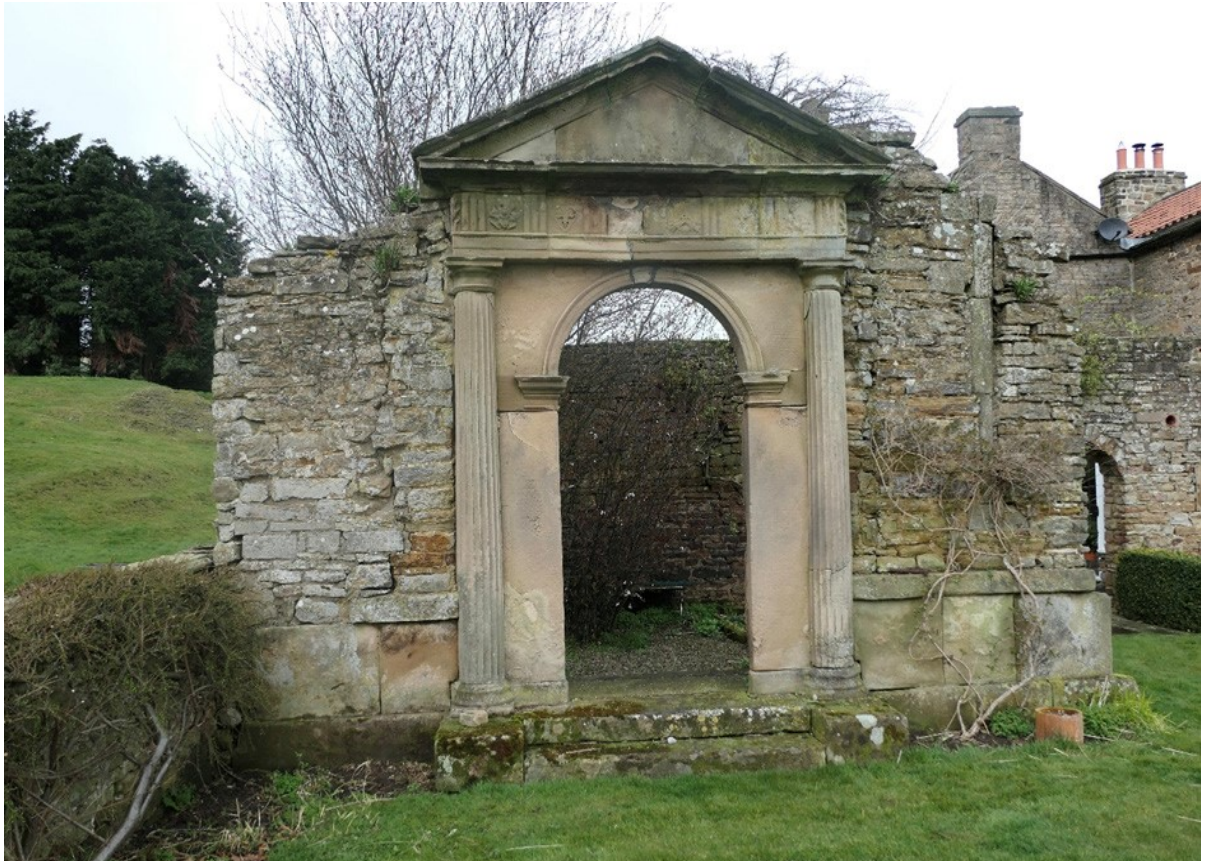
*Fig. 49 Doorway with Palladian-style doorcase.*

A doorway set in a 6m length of rubble walling stands on the lawn to the S of the farmhouse. Traditionally, this has been held to be a surviving part of the Jacobean manor house. The door surround is in the Palladian style with fluted Doric half-columns surmounted by a richly ornamented entablature and pediment. Dates around 1730/40 have been proposed for this structure. On either side of the doorway, a fine ashlar plinth lies at the base of the wall. As neither the plinth, nor the Palladian doorway, are shown on Buck's drawing, they must date later than c.1720 (Fig. 49).

Careful examination of the wall flanking the doorway shows that it is a composite structure, consisting of masonry of more than one period, and many hours have been spent discussing and analysing it.

As the stonework of the internal wall face has been reddened by fire, it can reasonably be assumed that the wall was standing in 1750 when the house burned down. Further indications of fire damage can be seen on the splayed reveals of the doorway opening where a vertical strip of paler sandstone, evidently unaffected by heat, contrasts with the adjacent fire-reddened stonework (Fig. 50). This shows where a wooden door, some 110mm thick, in place at the time of the fire, had protected the masonry from the intense heat.

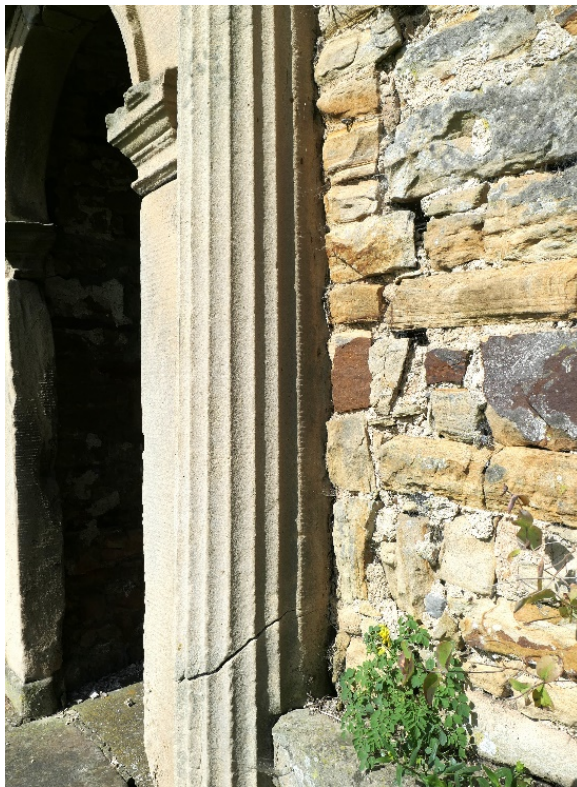
*Fig. 51 Lip on the edge of a column indicating the thickness of a coat of render*

It appears that Garrett also intended that the exterior stonework of the Jacobean house should be covered with render and the old mullioned windows replaced by more fashionable sashes. Thus, on both sides of the doorway, the carving of the fluted columns stops with a slight lip a couple of centimetres short of the wall surface (Fig. 51). We suggest that this gap represents the thickness of a coat of render. Again, it seems unlikely that the crude blocking of the mullioned window was intended to be seen and this too argues in favour of a rendered wall surface.

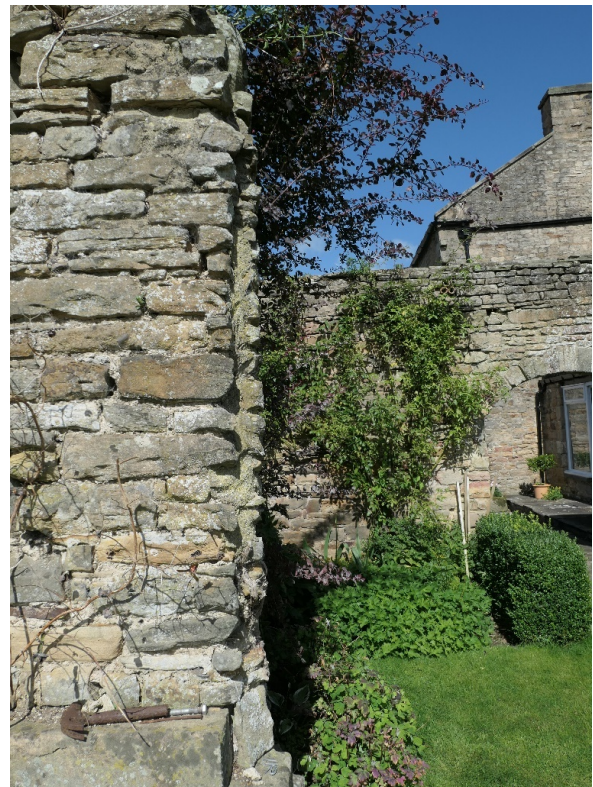
The evidence for sash windows consists of a rebate which runs vertically down the outer edge of the masonry blocking the mullioned window (Fig. 52). The most plausible explanation for this is that it was designed to house the frame of a sash window of less generous proportions than its predecessor.

*Fig. 52 The rebate in the blocking of the mullioned window designed to house the frame of a sash window. The hammer sits on the string course of the plinth believed to have been inserted by Garrett.*

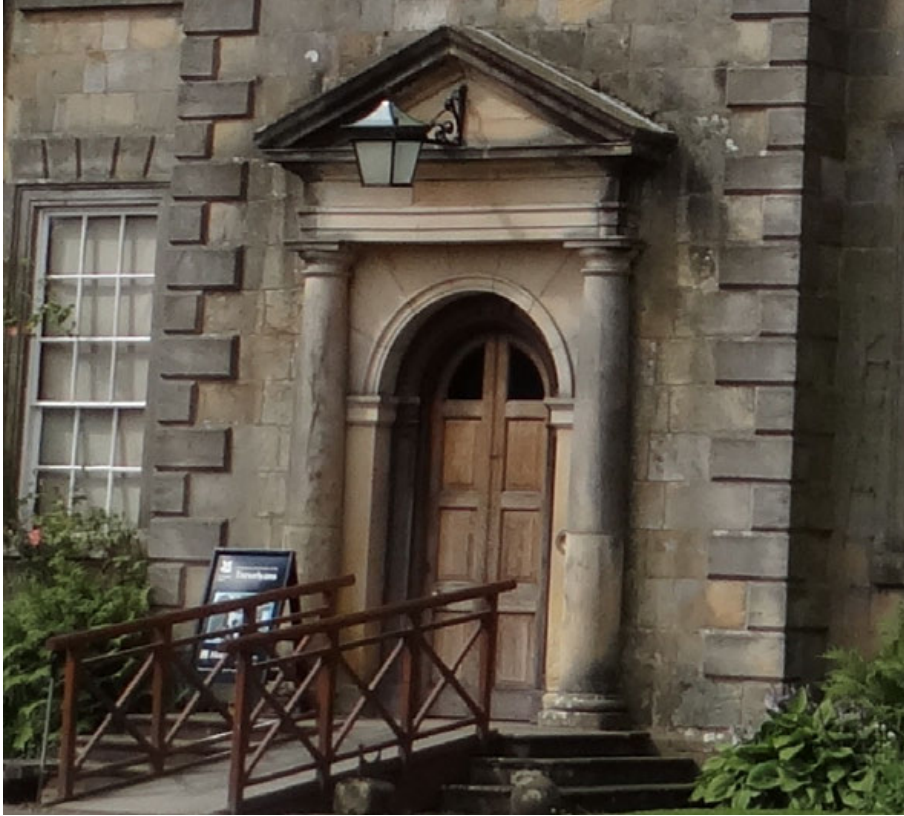
*Fig. 53. Wallington Hall. Doorway added by Garrett. Image supplied by Ed Kluz.*

Although it is difficult to prove solely on the basis of visible evidence, it is probable that Garrett took down the external porch turret shown in Buck's drawing so as to give the building a flat façade. While the Palladian doorcase might just have fitted within the porch turret of the old house this does not seem likely. Such a fine piece of decorative carving was surely intended to be seen from the garden and the lane beyond and not hidden away out of sight in a porch. At Wallington Hall, in Northumberland, Garrett added a very similar doorcase to the entrance on the E side of the house and it may be that he intended the same effect here (Fig. 53). Ultimately this is a question which only excavation can resolve.

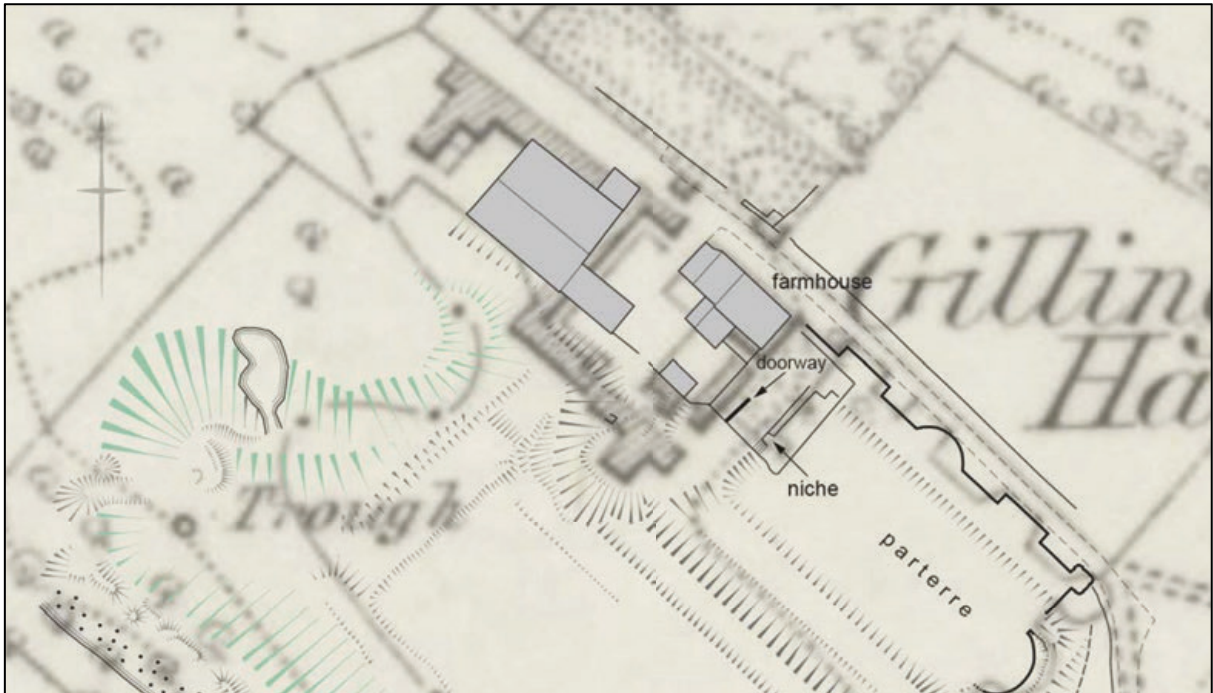
*Fig. 54 Earthwork survey overlaid on the first edition OS six-inch map (1857).*

If the first (1857) edition of the OS six-inch map is enlarged and superimposed onto the earthwork survey, it will be seen that the short arm of a T-shaped building fits neatly into the 'scoop' taken out of the terraces (Fig. 54). It seems, therefore, that the scoop was made to accommodate this building. As the scooping caused significant damage to the terraces, the T-shaped building, whatever it was, must be significantly later in date than the terraced garden but earlier than the survey of 1854.

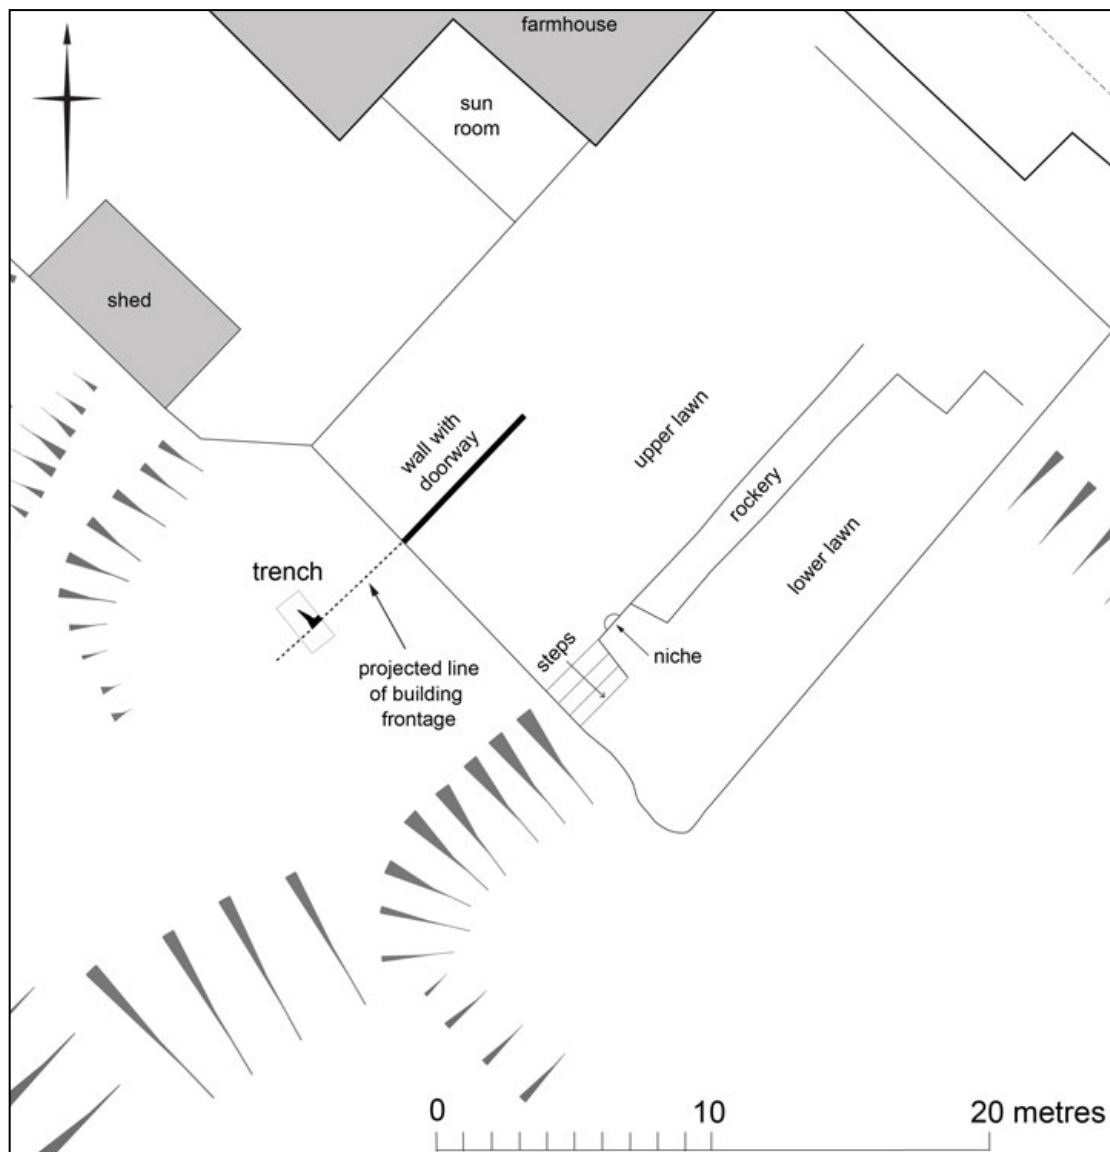
Fig. 56 Location of the trial excavation, October 2023.

In late October 2023, a trial excavation was undertaken in the rough grass field next to the walled garden to see if the wall of the Jacobean house could be intercepted on the same alignment as the standing wall with the doorway on the lawn nearby (Fig. 56).

A trench, measuring 2m by 1m, was set out 4m from the garden wall at right angles to the projected line of the standing wall so as to intersect a buried foundation or robber trench should there be one.

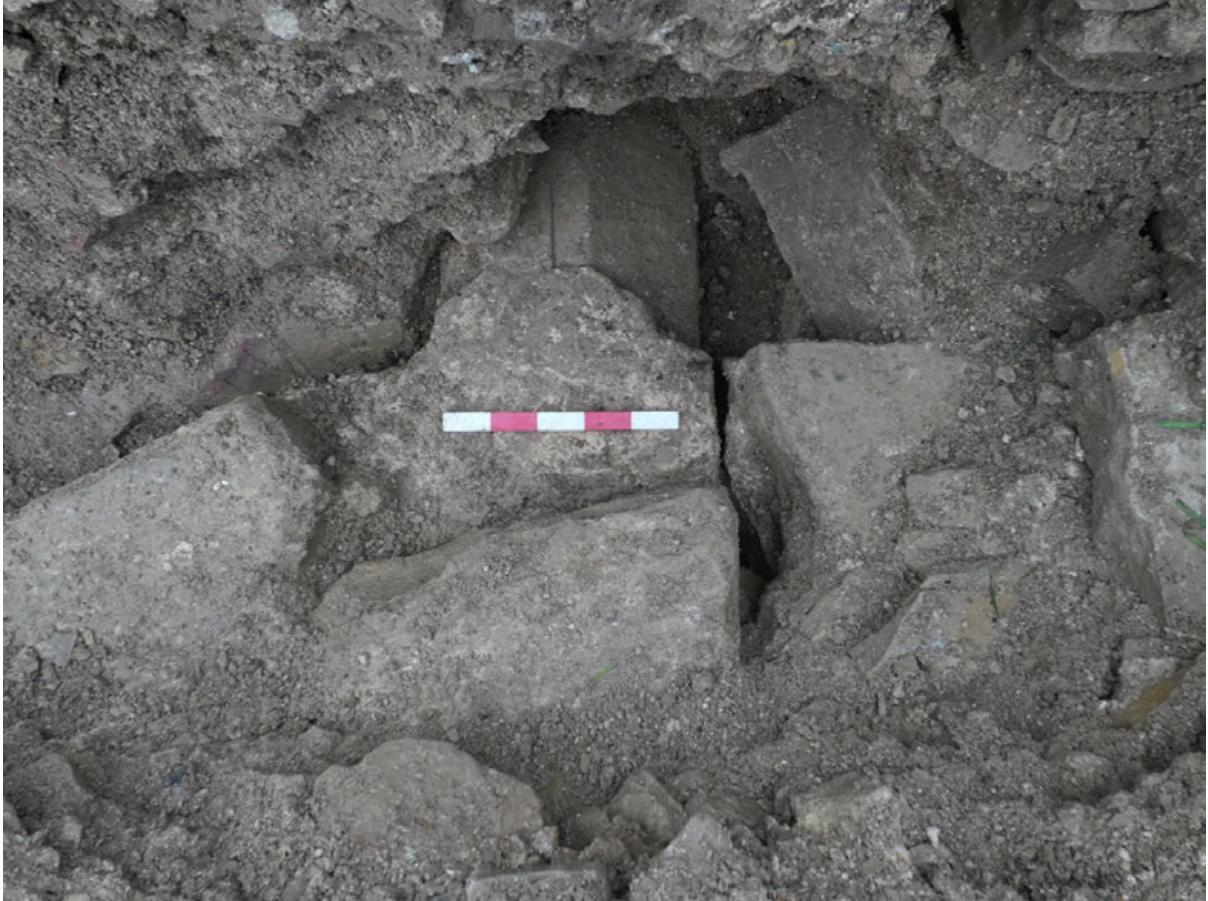
*Fig. 57 The finely carved and moulded window sill in situ. To the left of the scale the internal splay of the window opening can be seen.*

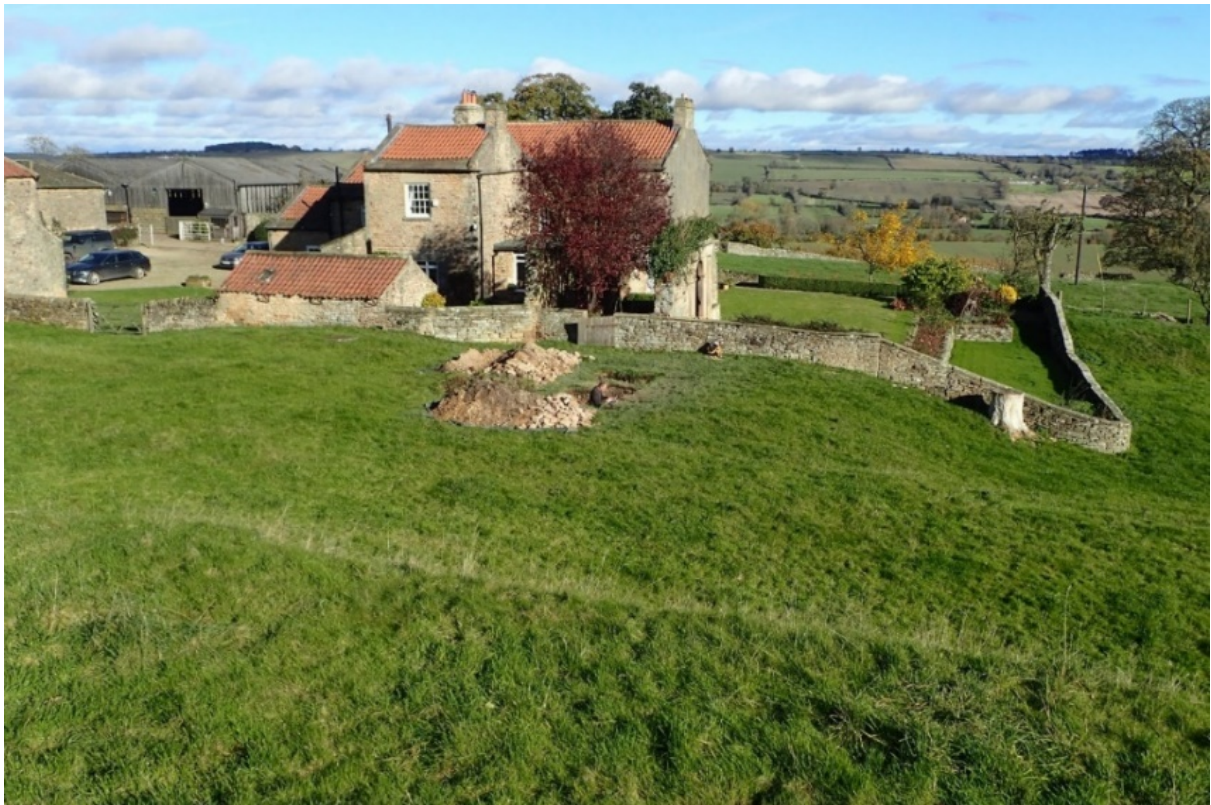
*Fig. 58 Location of the trenches opened in 2024.*

Three trenches were set out, numbered 1, 2 & 3 in the order in which they were dug. All were situated in the rough grass field to the south of the farmhouse and on the same alignment as the wall which supports the Palladian doorway in the neighbouring garden (Fig. 58).

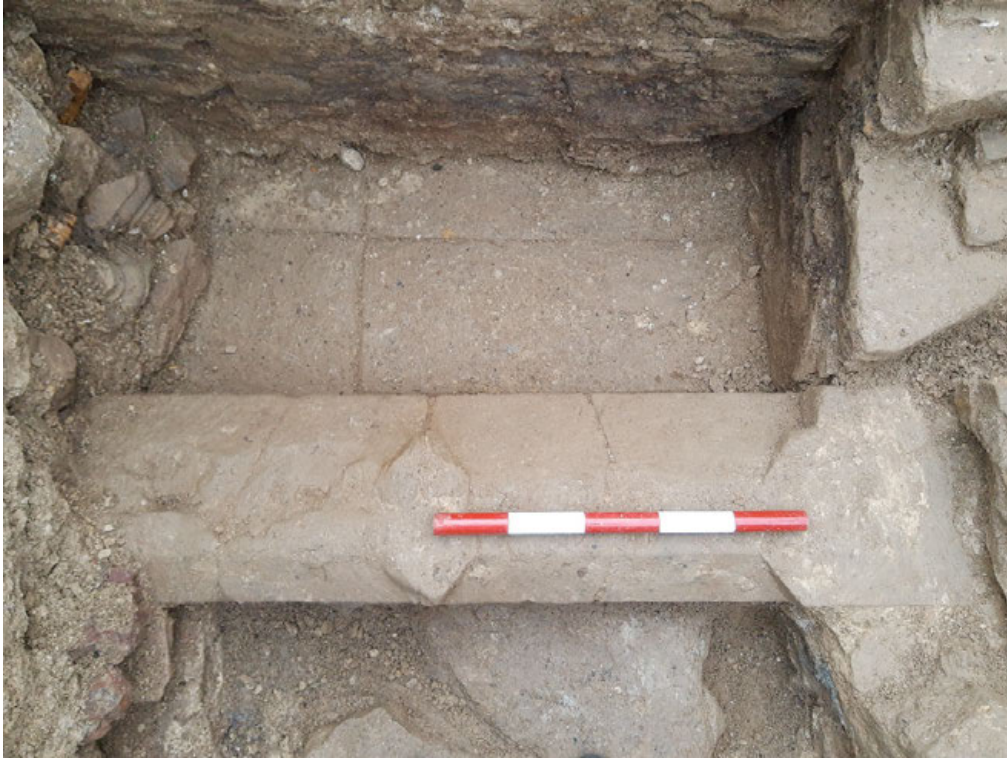
*Fig. 60 Window sill in Trench1.*

Although we didn't uncover the whole of the window sill seen last year, we were able to determine that the width of one glazed window light was 39cms (15½") (Figs. 60 & 61).

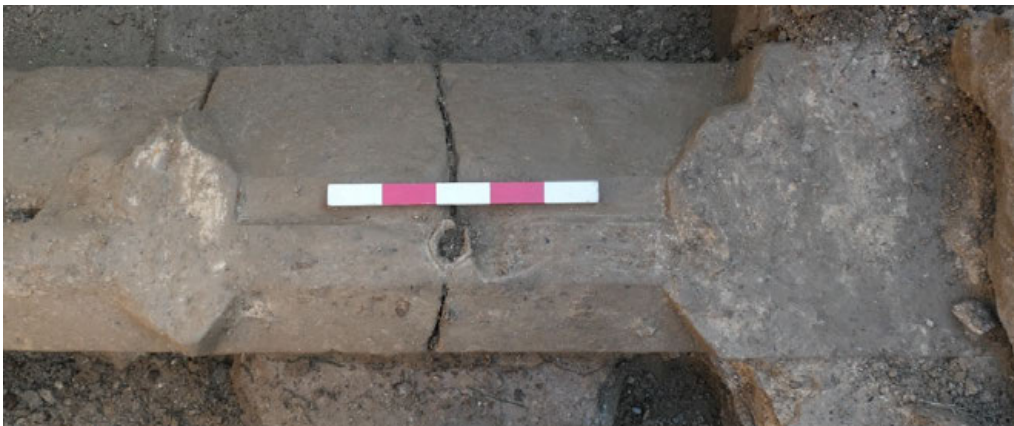
*Fig. 61 Trench 1. Detail of sill showing the hole for a vertical metal stanchion fixed in place with lead which remains in situ.*

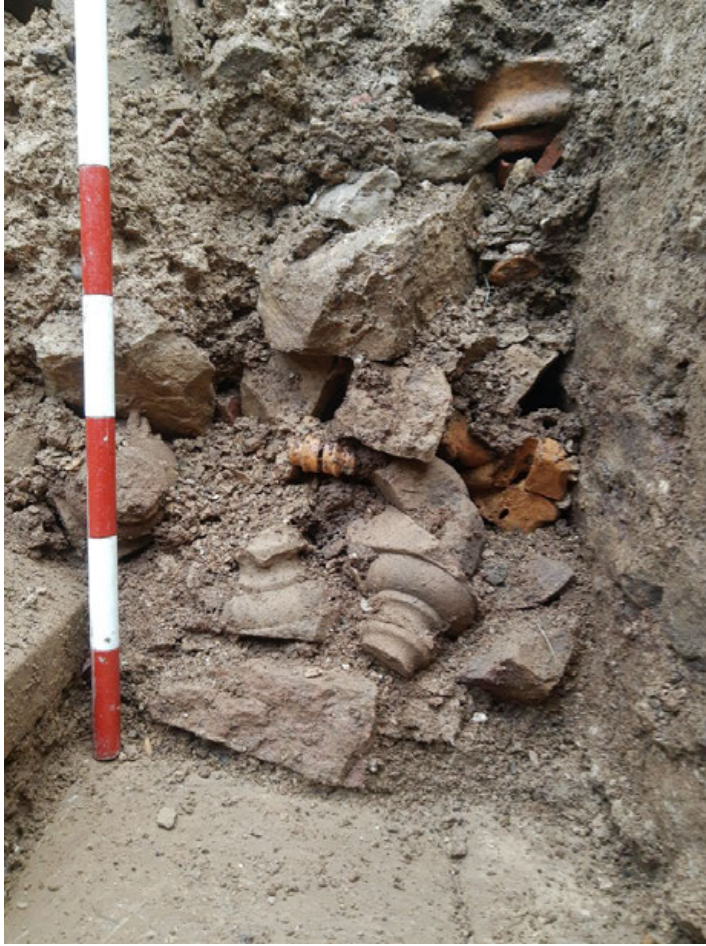
The rubble fill between the sill and the wall along the side of the trench to the SE contained a substantial quantity of animal bones together with over sixty pieces of carved sandstone from the balustrade of an external staircase (Fig. 62). As can be seen in the photograph, this material was piled up against the thick stone wall which projects into Trench 1 on the SE side. It must therefore be the case that the wall was already in place when the bones and the pieces of the balustrade were placed there.

*Fig. 62  
Trench 1. Pieces of a carved stone  
balustrade and animal bones in situ in  
the NE section of Trench 1.*

Approximately sixty baluster fragments from an external stone balustrade were recovered from Trench 1 all of which were carved from a pale yellow sandstone. Several more pieces were left in situ exposed in the face of the NE section (Fig. 62). All these fragments had been dumped into a void in front of the mullioned window belonging to the basement of the Jacobean mansion where they were loosely mixed with a quantity of animal bones and blocks of undressed stone. All of this material must have been deposited after the fire of 1750, though none of it showed signs of having been affected by heat.

Unburned animal bones were present in the rubble from all three trenches. In Trench 1 there was a significant deposit in the space between the basement window sill of the Jacobean house and the later wall which intrudes into the trench on the NE side. Some of these bones were left in situ (Fig. 62).

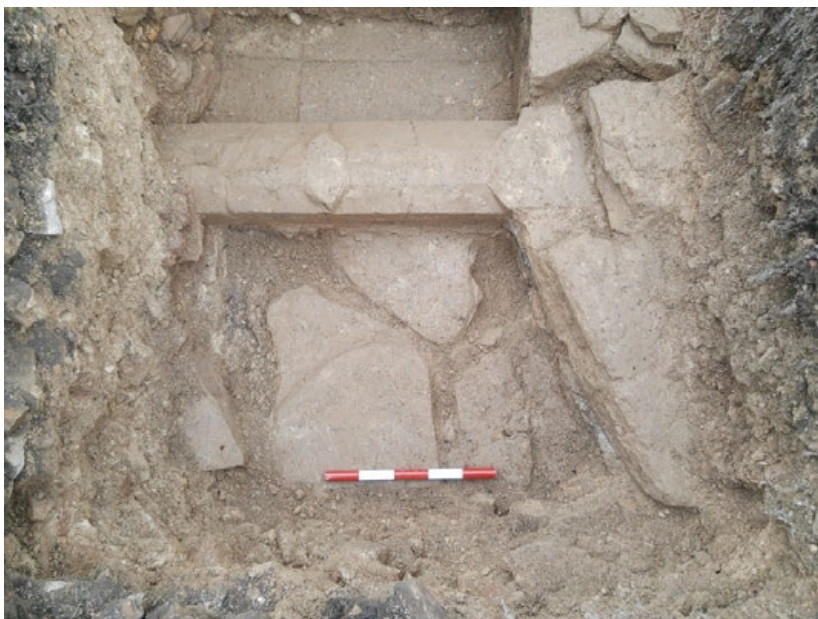
*Fig. 63  
Trench 1. Slabs forming a  
crude surface within the  
basement.*

Where the splayed window reveal was exposed (to the right of the sill in Fig. 63) remnants of plaster were found adhering to the wall.

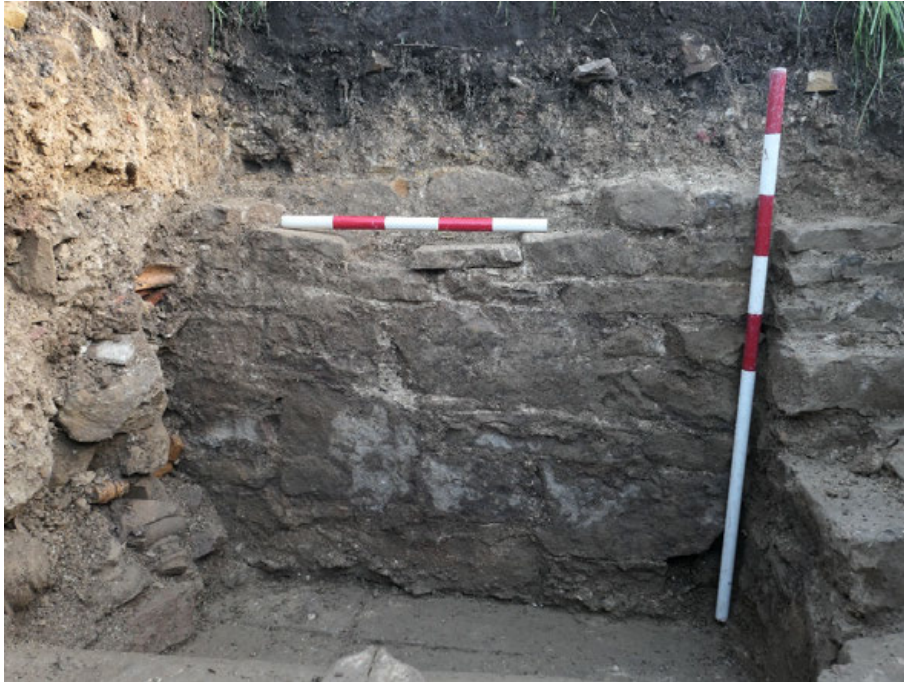
*Fig. 64  
Trench 1. Wall exposed  
in the SE section of  
Trench 1, overlying the  
flagstone pavement  
outside the basement  
window.*

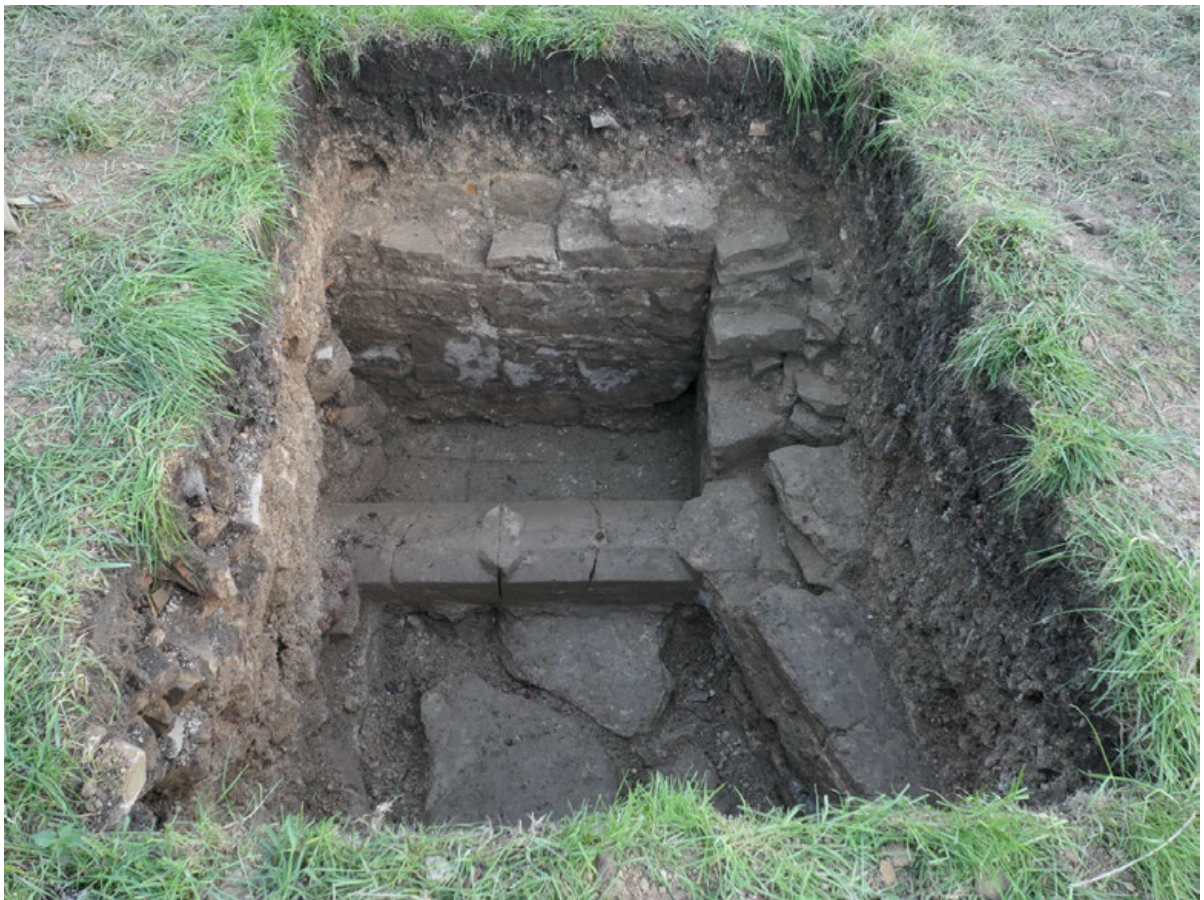
*Fig. 65 Overview of Trench 1 looking SE. Note that the wall exposed in the SE section overlies the flagstone surface and butts up against the wall thought to form part of a light well admitting light to the basement window.*

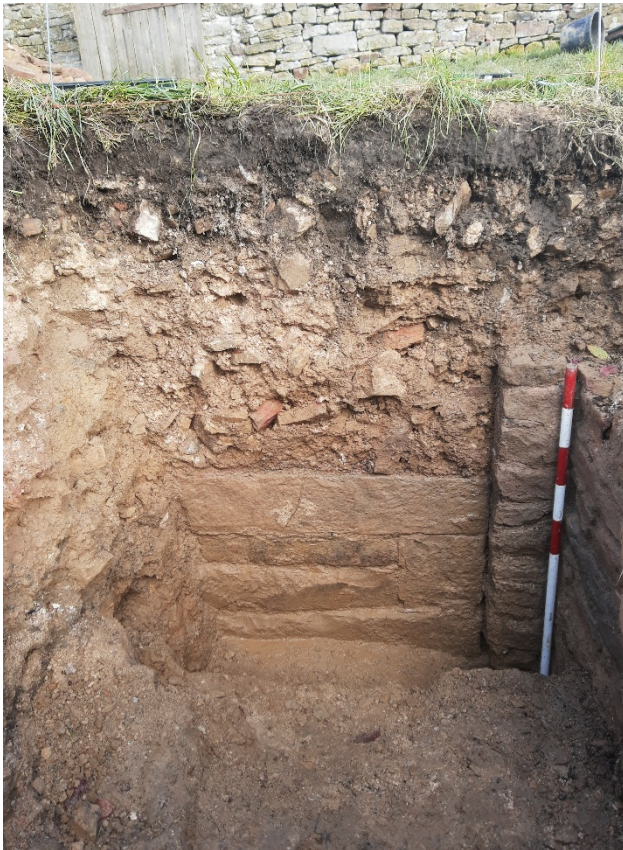
*Fig. 66  
Trench 2. The wall of the Jacobean hall is exposed in the section with a later wall (to the right) butting up against it.*

The upper courses of the wall of the Jacobean house appeared to have been robbed down to a level 0.9m below the turf. As no shaped blocks comparable to those remaining *in situ* were found in the demolition rubble, it is assumed that they were reclaimed or reused elsewhere.

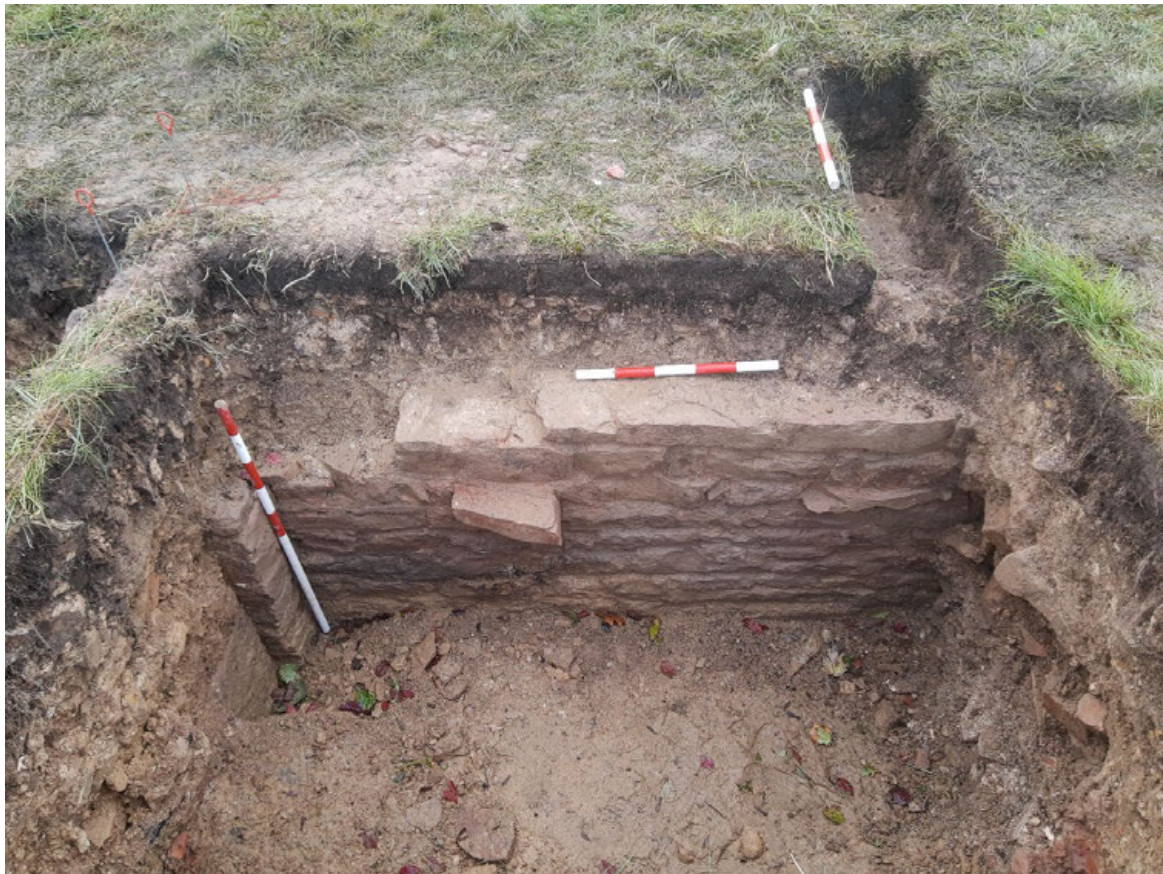
*Fig. 67 The one-metre-thick wall projecting into Trench 2. On the left, it can be seen to butt up against the corner of the Jacobean house. A 'slot' cut across the top of the wall (upper right) established that it was 1.0m broad.*

The face of this wall was also noticeably uneven, with two slabs projecting out from it by up to 0.2m (Fig. 67). This may indicate either that the wall was left unfinished, or that it is the foundation for a much higher wall and not intended to be visible.

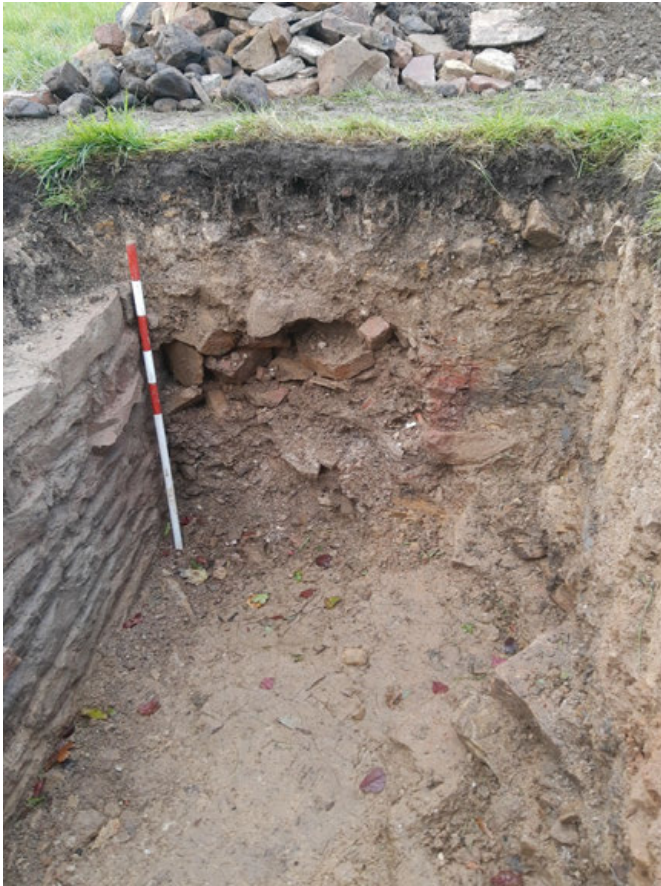
*Fig. 68  
The SW section of Trench 2 showing the  
foundation trench for the massive wall, seen  
here on the left.*

The foundation trench for this later wall is clearly visible in the SW section of Trench 2 (Fig. 68). At the level of the wall top, it measured 0.9m broad. The backfill of the trench consisted two distinct components: the lower fill was composed of relatively compact small stone rubble, while the upper was formed of a loose jumble of unshaped stone blocks. The more compact material in the lower part of the trench most probably represents backfilling contemporary with the construction of the wall. By contrast, the loose stone blocks could be the result of the partial demolition and robbing of the wall, most likely after the fire.

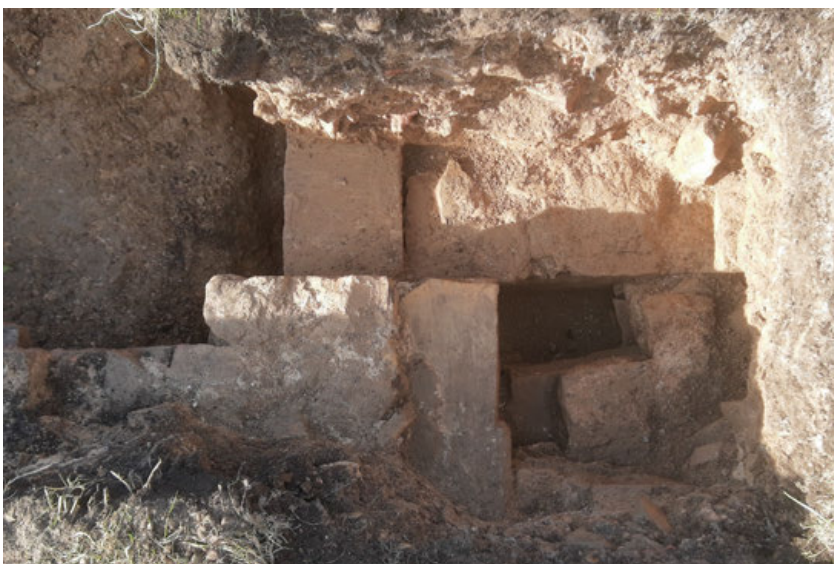
*Fig. 69  
Trench 3 In this vertical view,  
the later, massive wall (bottom  
left) can be seen to butt up  
against the corner of the  
Jacobean house (top centre).  
A partial void (lower right),  
which appears to interrupt the  
course of the later wall, was  
found to contain multiple  
fragments of wall or ceiling  
plaster (see Finds).*

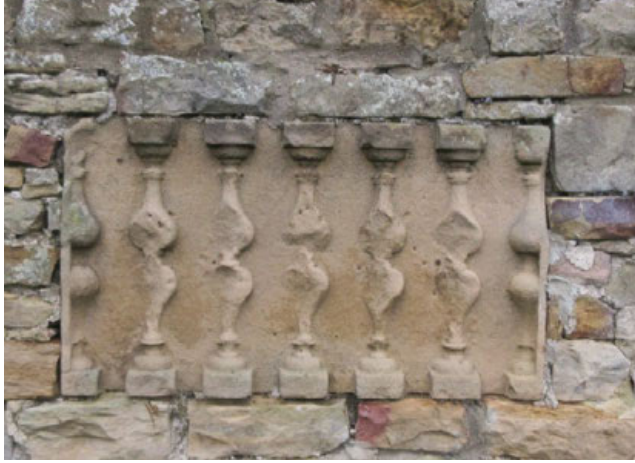
*Fig. 72  
Ex situ panel of mirror balusters in the  
outhouse wall, c. 1740, with elevational and  
sectional drawing.*

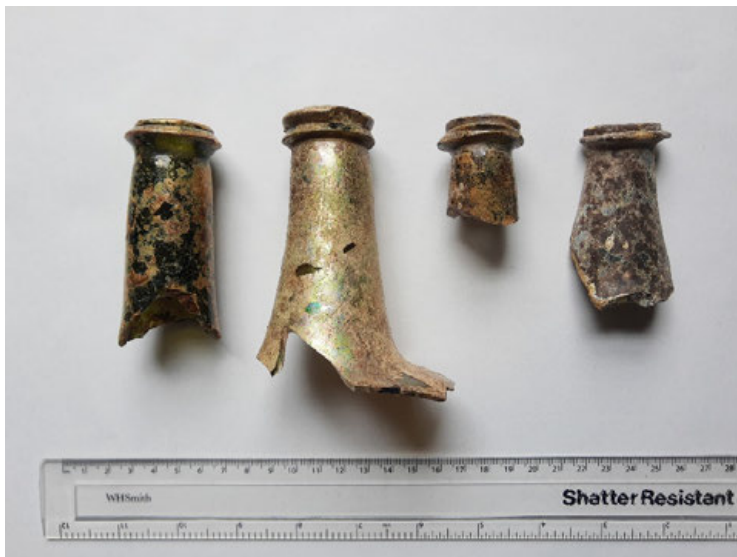
*Fig. 75 Bottle necks showing a variety of “string-rims”.*

The “string rims” varied in style (Fig. 75) but all were set close to the mouth of the bottle, and the neck end has been left just as it was after being pared off. Comparison with published examples from elsewhere would indicate dates in the first half of the 18<sup>th</sup> century (Haslam, 1970; Morgan, 1976).

Glass from broken wine bottles were found in all three trenches. Although no unbroken bottles were recovered, it would seem that all were of the “onion” form with an elongated neck, a globular body and a deep “kick” in the base. The glass varied in thickness from 2mm to 10mm. It was originally of a dark-green colour but when exposed to air most pieces became flaky and iridescent.

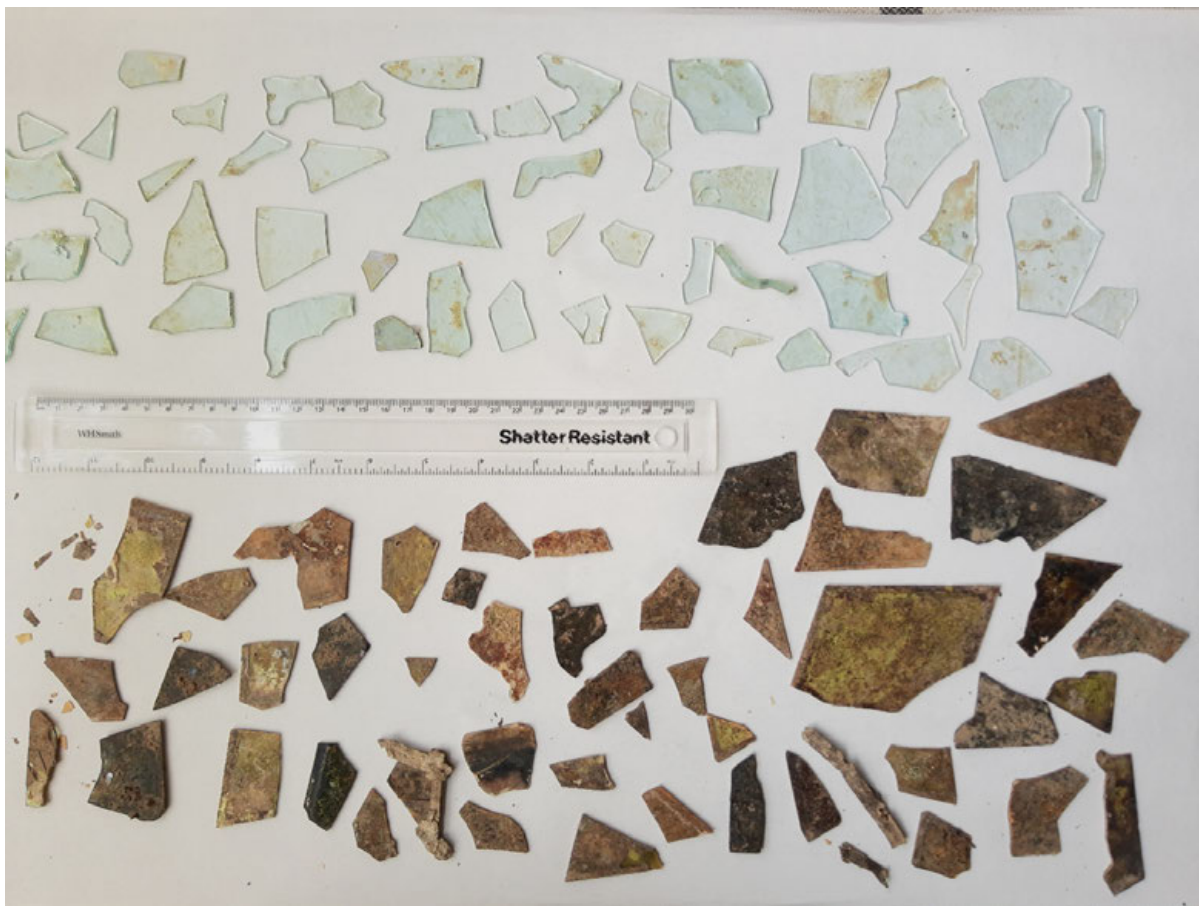
Two distinct types of window glass were recovered during the excavations, both made by the ‘crown sheet process’ (Cooper, 1835; Marson, 2022). One type of glass has a yellow tint and is relatively opaque; the other is clearer with a faint bluish tint. (Fig. 76). Due to its high content of vegetable-derived potash, the yellow-tinted glass is of poor quality and readily exfoliates on exposure to air. By contrast, the blue-tinted glass has a higher sodium content and is more durable.

*Fig. 76 Two types of window glass. Amongst the yellow-tinted glass one piece is still held in its lead came (bottom row, six pieces from the left). Many pieces of the blue-tinted glass exhibit heat fractures.*

Many pieces of the yellow-tinted glass have straight-cut edges which meet at sharply acute angles showing that they came from small, diamond-shaped panes. Edge marks showed where strips of lead came have become detached.

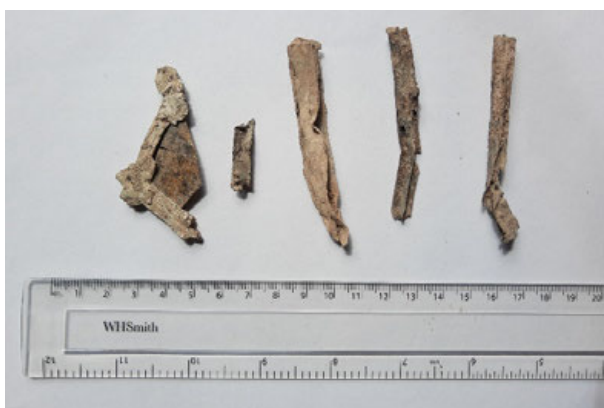
*Fig. 77  
Fragments of lead came from Trench 1.*

Only one piece only of the yellow-tinted glass was still sheathed in lead came. Another four short strips of came from which the glass had been separated were retrieved from Trench 1 (Fig. 77). The distance between the leaves of this came measured only 1.5 to 2.0mm, reflecting the thinness of the glass. The scarcity of came relative to the quantity of glass recovered is striking and is probably due to the lead having been reclaimed before the glass was discarded. It is also interesting to note that none of the yellow-tinted glass shows signs of having been exposed to heat, nor was there any melted lead present with the glass in Trenches 1 or 3.

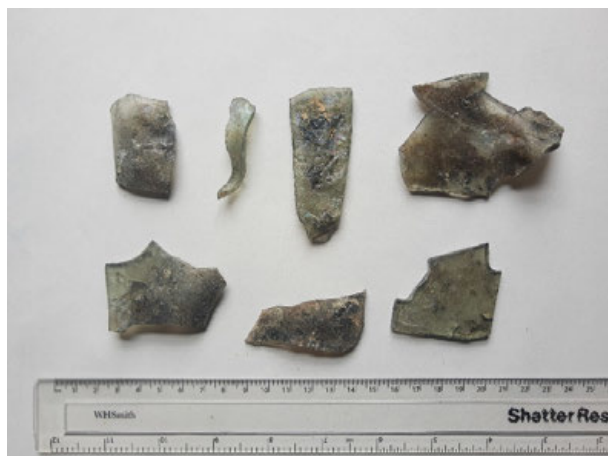
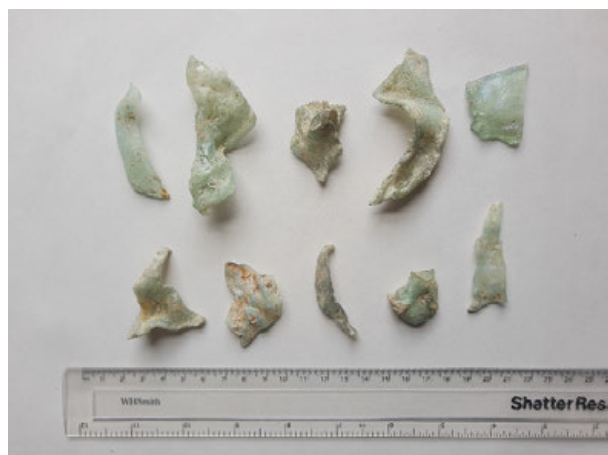
Trenches 2 and 3 produced small quantities of glass that was not like window glass or the glass from broken wine bottles. This other glass is of two types; an almost clear glass with pieces from 3.0 to 3.5mm thick; and slightly thinner glass with a pale green tint (Figs. 78 & 79). Keith Barley has provisionally identified this as vessel glass though what sort of vessel is not apparent. Interestingly, all this glass has been partially melted indicating that it has been exposed to temperatures around a thousand degrees centigrade.

*Fig. 78 Vessel glass (?) from Trench 2.*

*Fig. 79 Vessel glass (?) from Trench 2.*

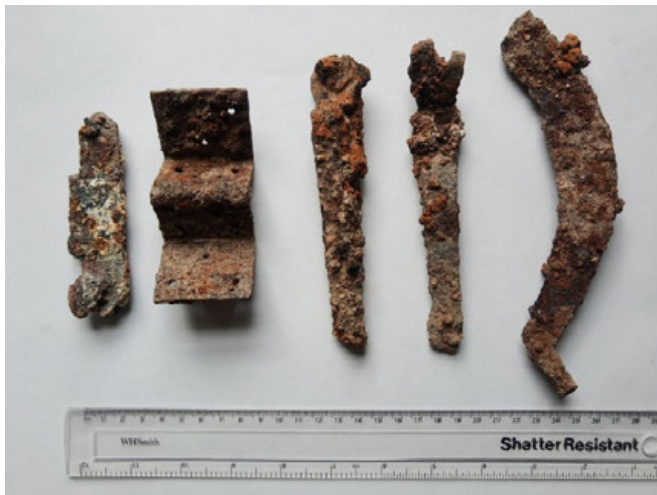
Trench 2 produced a variety of other iron objects including two hinges of different shape; a small sickle blade, a heavy spike flattened at the thick end to produce a (pierced?) flange, and a thin, strap-like fitting (Fig. 80).

*Fig. 80 Miscellaneous iron objects from Trench 2. From left to right, two hinges, a spike with a flattened end, a strap-like object, and a sickle blade.*

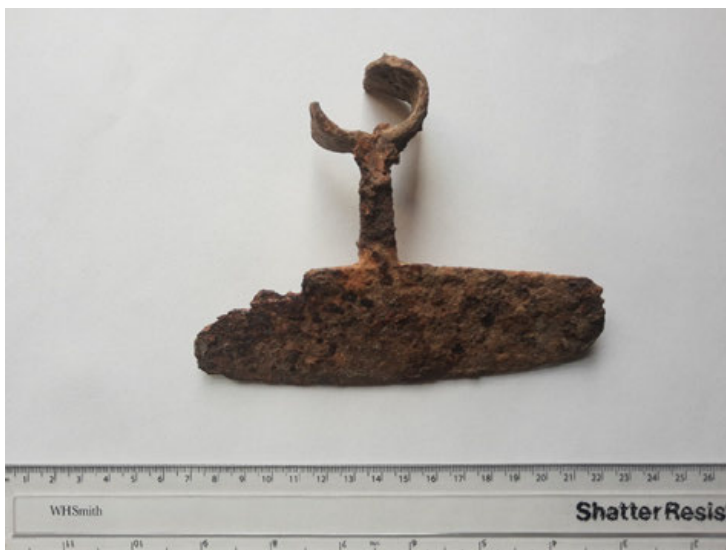
The corroded head of a garden hoe was recovered from the topsoil in Trench 1 (Fig. 81). Together with broken pieces of flower pot from the same context, it attests to the continuing use of the site as a garden in the 19<sup>th</sup> or earlier 20<sup>th</sup> century.

*Fig. 81  
Blade of a garden hoe from the topsoil in Trench 1.*
