Gillingwood Hall,  
near Richmond, North Yorkshire,  
and its historic garden:  
a final report

Scarborough Archaeological and Historical Society  
Report 69: 2026

National Grid Reference (approx centre) NZ 1710 0475  
National Grid Co-ordinates (approx centre) 41710 50475  
North Yorkshire HER No. 40333

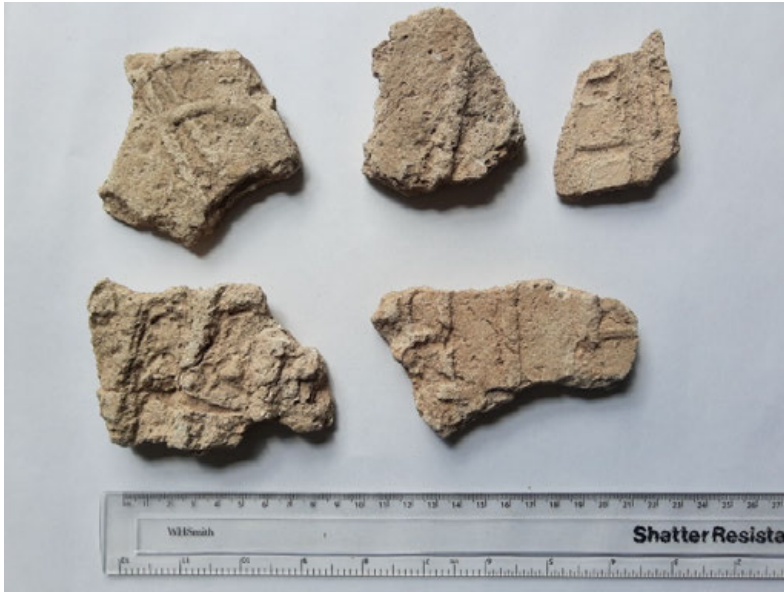
Amorphous lumps of mortar and plaster were found in the rubble in all three trenches as well as occasional pieces of plaster that bore the impressions of the lathes that had formed the support to which the plaster had been applied. In Trench 3, a cache of such material was found in a void next to the outside wall of the Jacobean hall (Fig. 82).

*Fig. 82 Wall or ceiling plaster with impressions of the supporting lathes.*

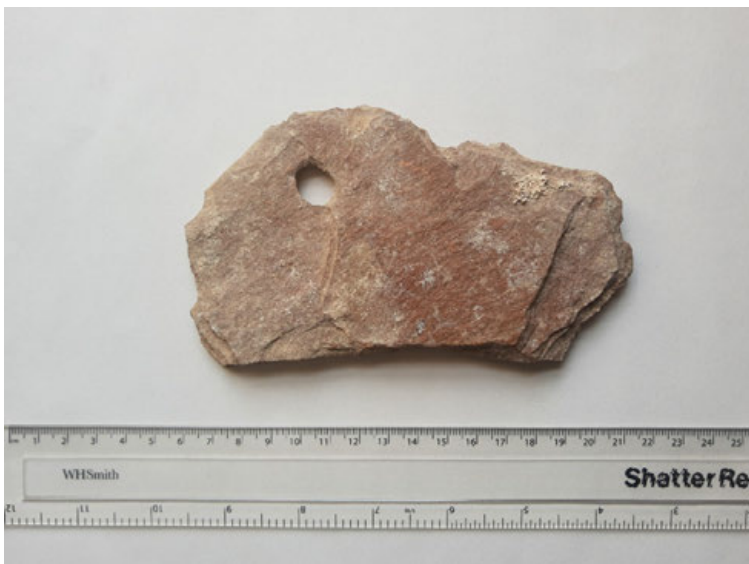
Three unshaped pieces of grey-green (Westmorland?) slate incorporated in the rubble in Trench 1 may represent broken roofing slates. A piece of reddish-brown slate pierced by a nail hole, recovered from the spoil heap, also looks like a broken slate (Fig.83). One side is covered in mortar, possibly indicating that the slate had been reused as building material.

*Fig. 83  
Broken roofing slate?*
