ARCHAEOLOGICAL EVALUATIONS
& EXCAVATIONS AT THE FORMER
PENTECOSTAL CHURCH
EASTBOROUGH, SCARBOROUGH

Report 36 2022

ARCHAEOLOGICAL
EVALUATIONS AND EXCAVATIONS
AT THE FORMER PENTECOSTAL CHURCH
EASTBOROUGH, SCARBOROUGH

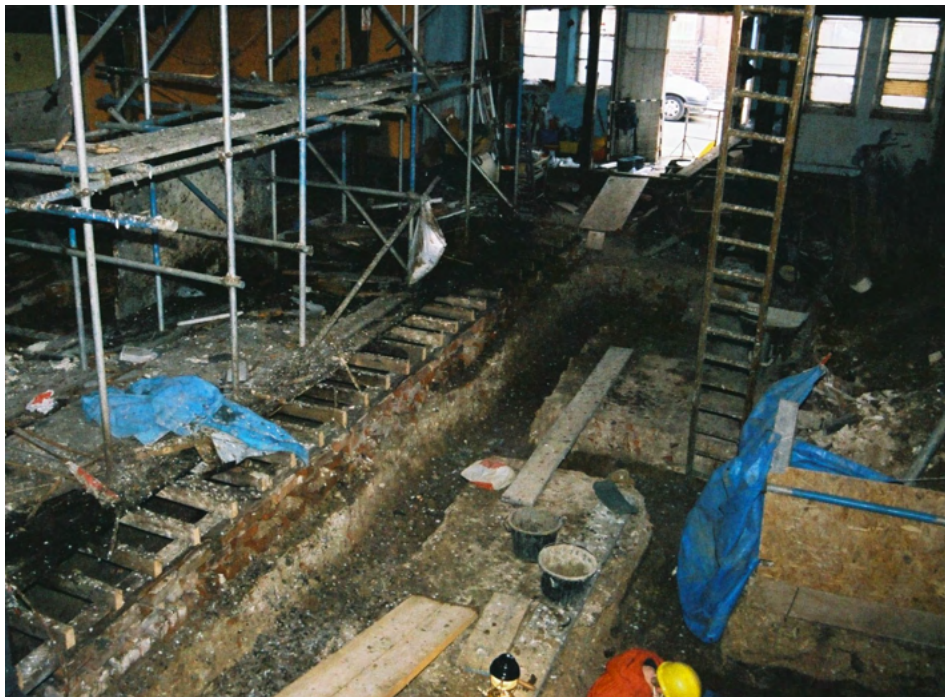
Fig 4 – the hand excavated trenches within the church in progress showing the difficult working conditions within the nave of the former church

5.2 In 2005 new proposals came forward for the redundant church involving its conversion to residential use with the associated erection of loadbearing internal walls and other groundworks. Before this work commenced, hand excavated evaluation trenches numbered 1 to 6 near to the east wall of the nave were excavated in March 2005 (Figures 3 and 4)

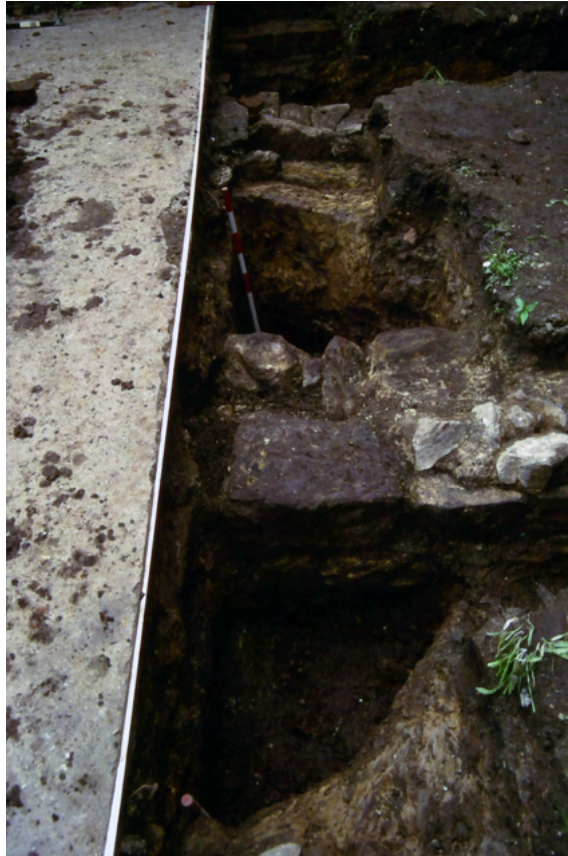
Fig 7 – looking along the south-east edge of 2003 trench showing pit 5017 bisected by wall 2004

- 6.2.4 03/F5017/F5023 formed the west side of a circular steep sided pit, the east side of which is outside the excavation trench. The feature is bisected by wall 03/F2004 (Figure 7) and hence the cut edge of the pit on either side of the wall was given a separate number, though there is no doubt that they are one and the same feature. The south-west quarter of the pit (03/F5017) was slightly undercut 0.5m from the top of the feature. The lowest excavated fill in the south-west quarter of the pit consisted of a dark brown organic deposit (layer 03/5016) which became increasingly organic with depth. A 20 litre sample of this deposit was taken for analysis for environmental remains. The results of this analysis are set out in Annex 1. Below this the fill was clayey. Due to safety considerations this deposit was not excavated but may be close to the base of the pit due to its clayey composition. The pit was overlain by layer 03/5014 - a mixed brown clay with extensive charcoal inclusions. In the north-west quarter of the pit (03/F5023) the deposit went from a clayey organic deposit, the equivalent to layer 03/5014, to a more organic deposit equivalent to layer 03/5016. Both these fills were given a single number of 03/2006. Excavation of the north-west quadrant ceased at a higher level than the south-west quadrant.

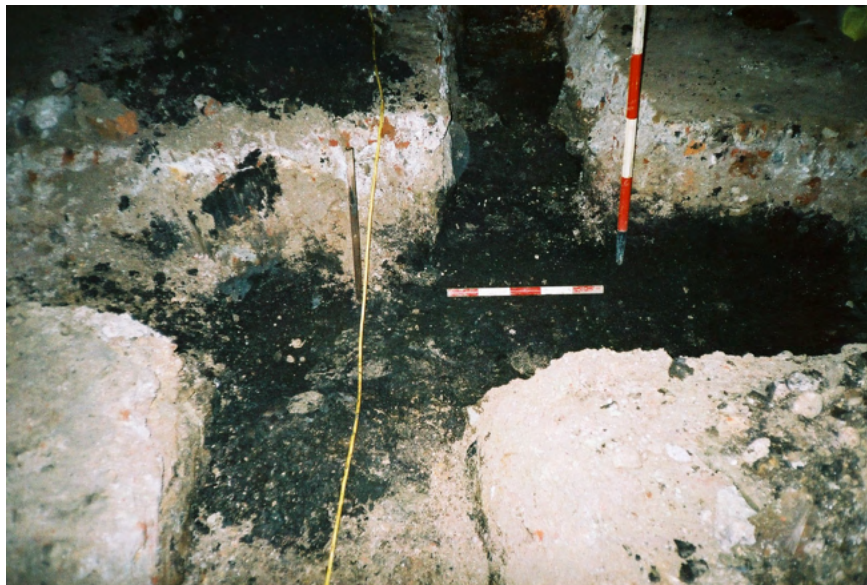
Fig 8 – the black organic material revealed following the machine excavation of the foundation trenches 7023 and 7025

- 6.2.6 In 2005 within the south-west corner of the building further evidence of pit digging was found in the form of three large areas of dark black organic material (Figures 3 and 8).

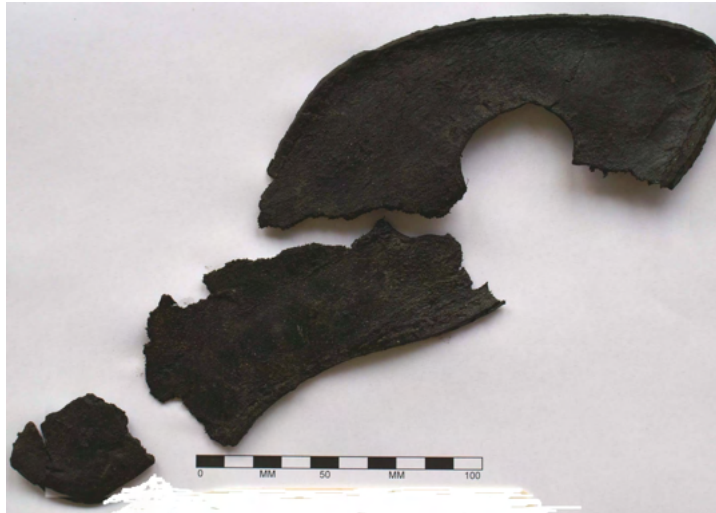
Fig 9 – example of the leather found in 05/7023

These organic deposits contained pottery, bone, fragments of leather (Figure 9), timber and textile. Feature 05/7023 was sample excavated and it was found that the organic material at this point was 2 metres deep, sitting directly upon and within natural clay. 05/7024 and 05/7025 were not excavated to their full depths. One significant piece of worked wood (Figure 10) was possibly a peg, a tool handle or a small finial.

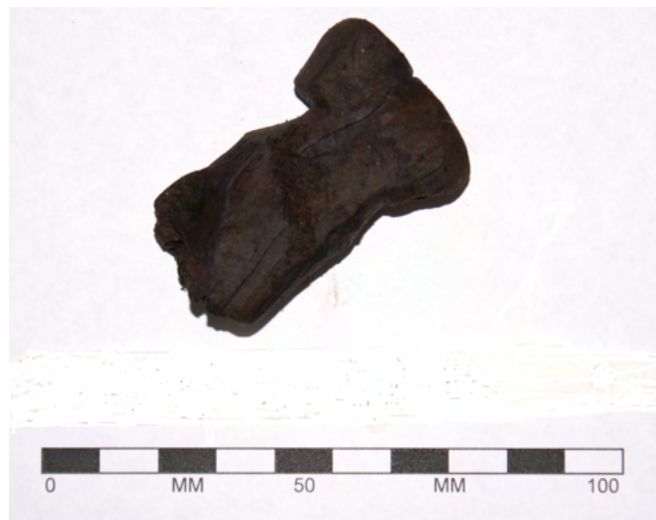
Fig 10 – the wooden object found in context 05/7023

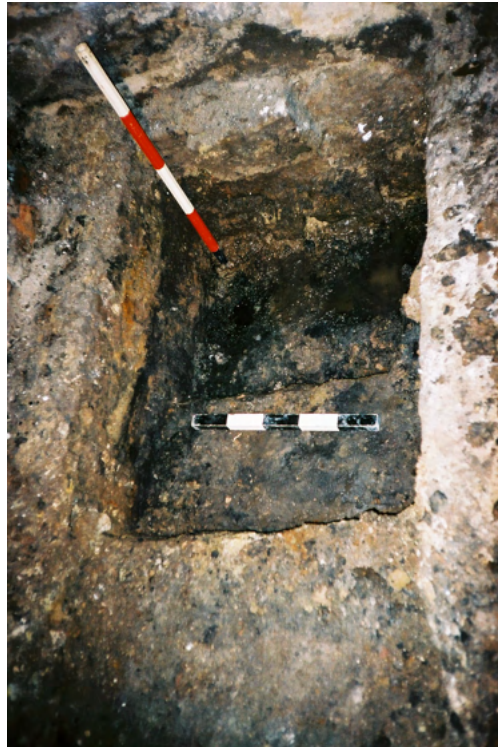
Fig 11 – Trench 8

6.2.7 A small evaluation trench, 8, (Figures 3 and 11) was put down immediately south-east of a substantial stone cross wall 05/F8009

which forms the south end of the aisle to the nave. The purpose was to provide further interpretation on the organic finds in 05/7023. The excavation of the evaluation trench was curtailed due to ingress of water but it did reveal a slightly curvilinear cut 05/F8010 into the clay filled by organic deposit excavated in pits 05/8003 to 05/8008 showing that the material was part of a large midden pit similar to that found in 2003.

- 6.3.5 In Trench, 8, hand excavated in 2005 a substantial stone cross wall 05/F8009 which forms the south-west end of the aisle to the nave was found to pre-date the current 1868 church and is possibly the south-east and south-west re-entrant walls of the earlier Independent Chapel, though it may incorporate medieval fabric. The evaluation trench showed that this stone wall 'bridges' the organic deposit, and was therefore later than it, and indeed the poor ground conditions had resulted in the necessity of a relieving arch being incorporated in the masonry.

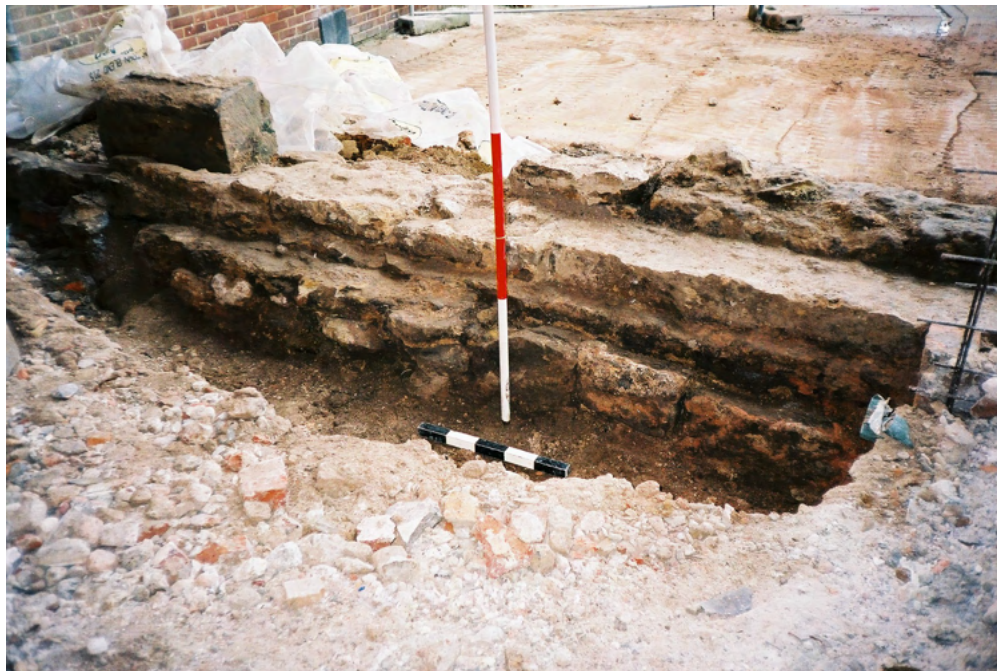
Illustration – the stone masonry revealed following the removal of the brick east wall

6.5.3 In 2005 following removal of the upper courses of brickwork in the east wall of the former church, the stone wall was recorded, revealing that it had completely separate inner and outer leaves, the outer possibly being older. Monitoring of the adjacent foundation trenches showed that the stone wall was built off clay, though exclusively medieval pottery was found in the vicinity of the wall and this confirms the findings set out in paragraph 6.5.2.
